# JOINT INVESTIGATION REPORT

INCIDENT NO: 2284480 JIV report S/N: 0261

1. Spill incident Number: 2284480 2. Type of incident\* OIL SPILL  
3. Name of Location 12" IMO RIVER - OGALE PIPELINE  
4. Name of nearest community OGALE 5. State: RIVERS 6. LGA ELEME  
7. Type of Production facility/Installation OIL PIPELINE  
8. Asset owner/District THE SHELL PETROLEUM DEVELOPMENT COMPANY OF NIGERIA LTD (SPDC)/PIPELINE

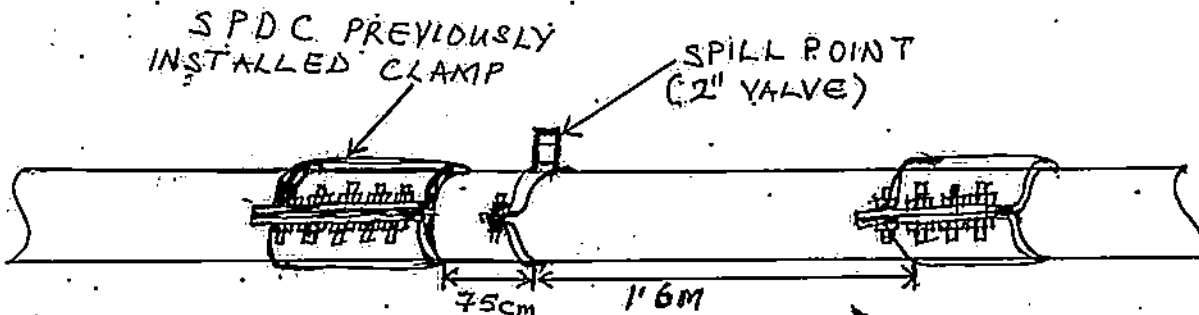
**E. GRAPHIC DESCRIPTION OF LEAK POINT** (while detailed report of the leak point should be contained in the leak report, overview sketch of the site should be added as an appendix 1) A SECTION OF 12" IMO RIVER - OGALE PIPELINE AT OGALE SHOWING 2" VALVE CRUDE THEFT POINT (SPILL POINT) INSTALLED AT 12 O'CLOCK POSITION 75CM FROM PREVIOUSLY INSTALLED CLAMP

REPAIR BY CLAMPING
