# JOINT INVESTIGATION REPORT

INCIDENT NO: 2285488 JIV report S/N: 0228

1. Spill incident Number: 2285488 2. Type of incident\*: OIL SPILL  
3. Name of Location: 12" IMO RIVER - OGALE PIPELINE  
4. Name of nearest community: UZUAKU 5. State: ABIA 6. LGA: UKWA-WEST  
7. Type of Production facility/Installation: OIL PIPELINE  
8. Asset owner/District: THE SHELL PETROLEUM DEVELOPMENT COMPANY OF NIGERIA LTD (SPDC)/PIPELINE

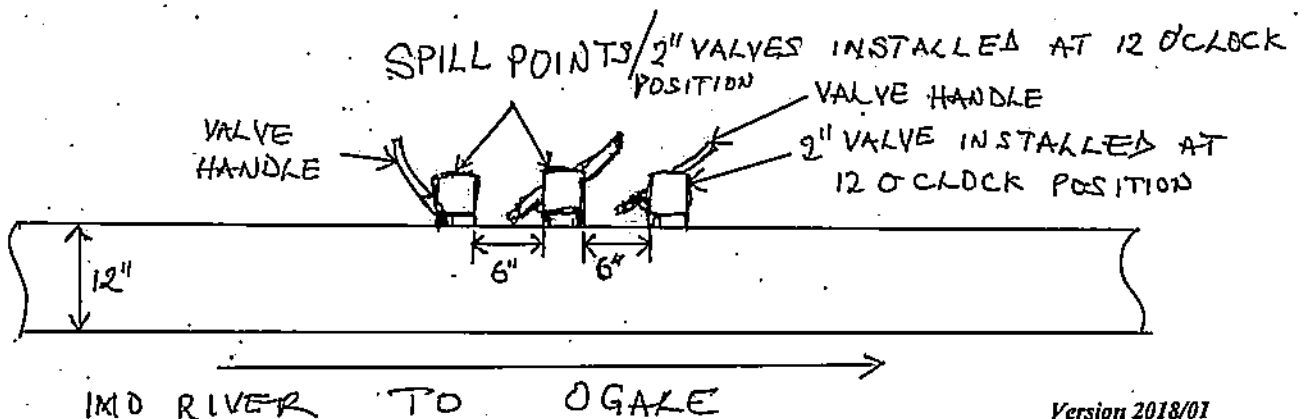
**E. GRAPHIC DESCRIPTION OF LEAK POINT** (while detailed report of the leak point should be contained in the leak report, overview sketch of the site should be added as an appendix 1) A SECTION 12" IMD RIVER

- OGALE PIPELINE AT UZUAKU SHOWING 2" VALVES AND CRUDE TRAPT POINT INSTALLED 6" FROM EACH AT 12 O'CLOCK POSITIONS BY UNKNOWN PERSONS:

REPAIR BY CLAMPING
