JOINT INVESTIGATION REPORT

INCIDENT NO: 2280272 JIV report S/N: 0169

1. Spill incident Number: 2280272 2. Type of incident: FIRE/OIL SPILL
3. Name of Location: 28" BOMU - BUNNY TRANS NIGER PIPELINE
4. Name of nearest community: OWOKIRI 5. State: RIVERS 6. LGA: ANDONI
7. Type of Production facility/Installation: APL PIPELINE
8. Asset owner/District: THE SHELL PETROLEUM DEVELOPMENT COMPANY OF NIGERIA LIMITED PIPELINE

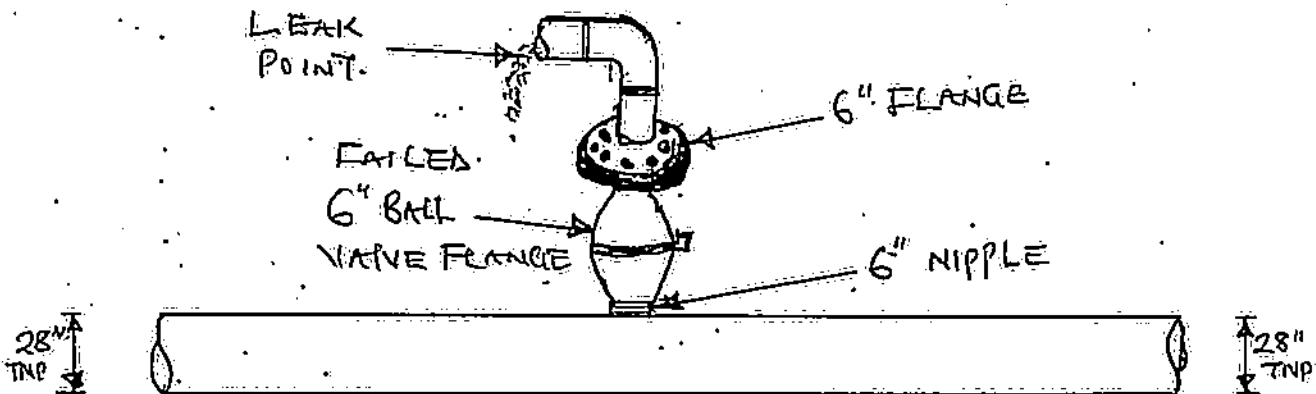
BOMU - BONNY PIPELINE

Additional observations around the spill point: THE JOINT INVESTIGATION TEAM, UPON ARRIVAL AT THE INCIDENT POINT OBSERVED BURNT SOIL AROUND INCIDENT POINT, THIS SHOWS THAT THE INCIDENT WAS ACCOMPANIED BY FIRE.

| <input checked="" type="checkbox"/> Failed Weld-on illegal hot tap valve | <input type="checkbox"/> Failed Clamp | <input type="checkbox"/> Missing Pipeline/Flowline |
| <input checked="" type="checkbox"/> Crude oil theft (illegal bunkering) point | <input type="checkbox"/> Saver-pit over flow | <input type="checkbox"/> Third-party tampering with Clamp |

SECTIONAL VIEW OF 28" BOMU-BONNY TRANS NIGER PIPELINE AT
ONOKIRI SHOWING: - FAILED 6" BALL VALVE FLANGE INSTALLED AT 12
O'CLOCK POSITION BY UNKNOWN PERSON(S)

REPAIR WORK BY CLAMPING ON-CEGNG
