JOINT INVESTIGATION REPORT

INCIDENT NO: 2296972 JIV report S/N: 0255

1. Spill incident Number: 2296972 2. Type of incident*: OIL SPILL
3. Name of Location: 36" NKPOKU - BOMU PIPELINE
4. Name of nearest community ELELEND 5. State: RIVERS 6. LGA OBIO/AKPOR
7. Type of Production facility/Installation OIL PIPELINE
8. Asset owner/District THE SHELL PETROLEUM DEVELOPMENT COMPANY OF NIGERIA LIMITED / PIPELINE

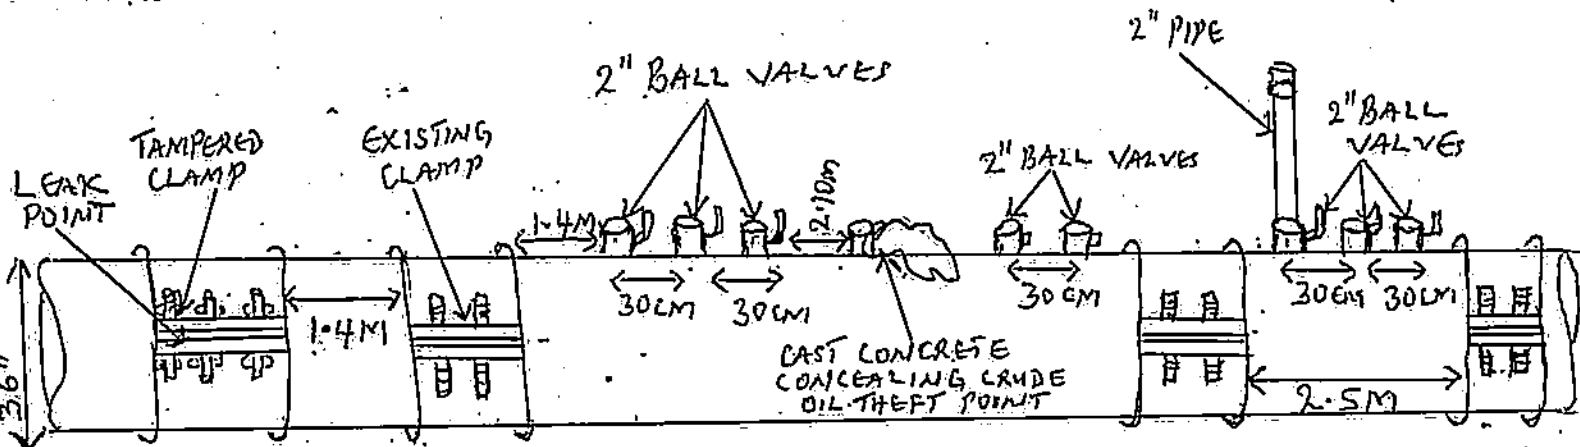
Additional observations around the spill point: THE JOINT INVESTIGATION TEAM OBSERVED TAMPERED CLAMP AND MULTIPLE CRUDE OIL THEFT POINTS INSTALLED BY UNKNOWN PERSONS.

SECTION OF 36" NKPOKU - BOMU PIPELINE AT ELELENWIO
SHOWING POSITIONS OF TAMPERED CLAMP AND MULTIPLE CRUDE OIL THEFT POINTS.

RECOVERY AND REPAIR ACTIVITIES ARE ONGOING
