JOINT INVESTIGATION REPORT

INCIDENT NO: 2301225 JIV report S/N:0265

1. Spill incident Number: 2301225 2. Type of incident* OIL SPILL
3. Name of Location 8" NKALI - IMORIVER 2 PIPELINE
4. Name of nearest community ODAGHWA 5. State: RIVERS 6. LGA ETCHE
7. Type of Production facility/Installation OIL PIPELINE
8. Asset owner/District THE SHELL PETROLEUM DEVELOPMENT COMPANY OF NIGERIA LIMITED / PIPELINE

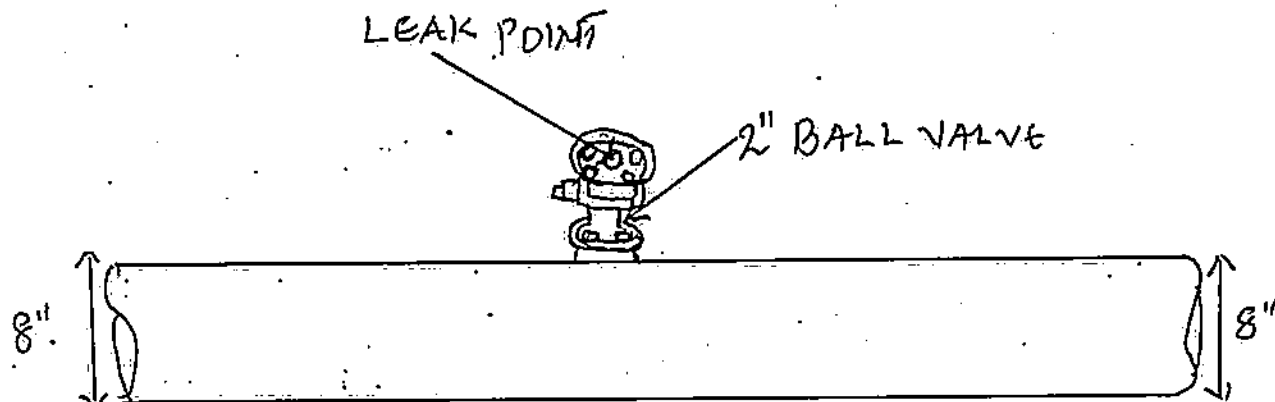
A SANDBAG WAS OBSERVED CONCEALING THE CRUDE OIL THEFT POINT.

| <input checked="" type="checkbox"/> Failed Weld-on illegal hot tap valve | <input type="checkbox"/> Failed Clamp | <input type="checkbox"/> Missing Pipeline/Flowline |
| <input checked="" type="checkbox"/> Crude oil theft (illegal bunkering) point | <input type="checkbox"/> Saver-pit over flow | <input type="checkbox"/> Third party tampering with Clamp |

SECTION OF 8" NKALI - IMORIVERZ PIPELINE AT ODAGWA SHOWING CRUDE OIL THEFT POINT INSTALLED AT 12 O'CLOCK POSITION.

REPAIR ACTIVITY Ongoing
