JOINT INVESTIGATION REPORT

INCIDENT NO: 2301224 JIV report S/N: 0268

1. Spill incident Number: 2301224 2. Type of incident*: OIL SPILL
3. Name of Location 36" NKPOKU BOMU PIPELINE
4. Name of nearest community ATALI 5. State: RIVERS 6. LGA OBIO-AKPOR
7. Type of Production facility/Installation OIL PIPELINE
8. Asset owner/District THE SHELL PETROLEUM DEVELOPMENT COMPANY OF NIGERIA LIMITED | PIPELINE

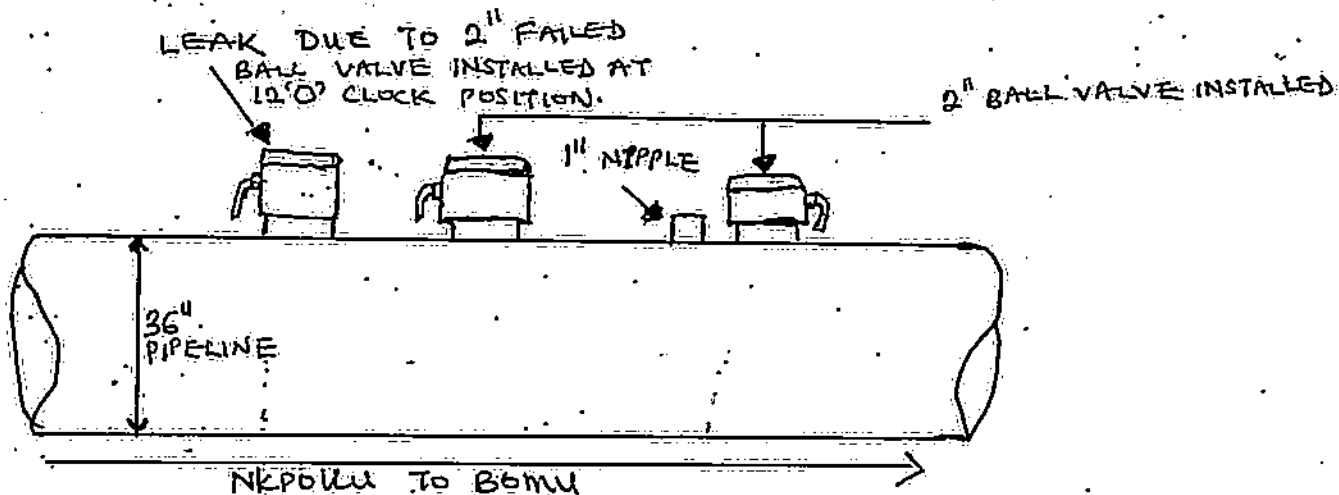
SECTIONAL VIEW OF 36" NKPOKU BOMU PIPELINE AT ATALI, SHOWING THREE (2") BALL VALVE AND (1") NIPPLE. ILLEGALLY INSTALLED AT 12 O' CLOCK POSITION.
