JOINT INVESTIGATION REPORT

INCIDENT NO: 2305712 JIV report S/N: 0280

1. Spill incident Number: 2305712 2. Type of incident*: OIL SPILL
3. Name of Location: 28" NKPOKU - BOMU PIPELINE
RUMUOWHA.
4. Name of nearest community: ENEKA. 5. State: RIVERS 6. LGA: OBIO/AKPO
7. Type of Production facility/Installation: OIL PIPELINE
8. Asset owner/District: THE SHELL PETROLEUM DEVELOPMENT COMPANY OF NIGERIA LTD (SPDC)
PIPELINE.

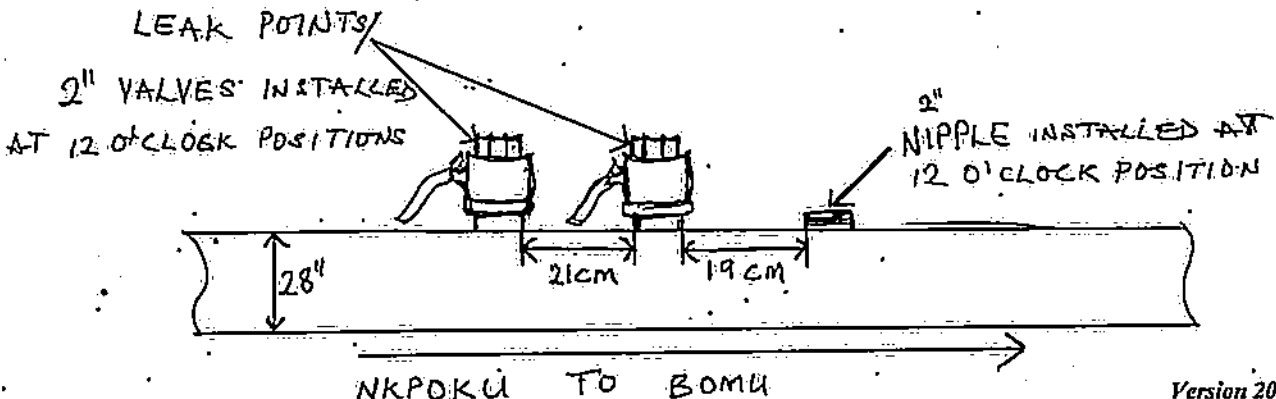
E. GRAPHIC DESCRIPTION OF LEAK POINT (while detailed report of the leak point should be contained in the leak report, overview sketch of the site should be added as an appendix 1) A SECTION OF 28" NKPOKU - BOMU PIPELINE AT RUMUDWA - ENIKA SHOWING 2 NOS 2" VALVE SPILL POINTS. INSTALLED 21CM APART AT 12 O'CLOCK POSITIONS AND A 2" NIPPLE INSTALLED 19CM FROM THE SPILL POINT AT 12 O'CLOCK POSITION BY UNKNOWN PERSONS

REPAIR BY CLAMPING
