JOINT INVESTIGATION REPORT

INCIDENT NO: 2301235 JIV report S/N: 0257

1. Spill incident Number: 2301235 2. Type of incident: OIL SPILL
3. Name of Location: 10th DIEBU CREEK - NUN RIVER PIPELINE
4. Name of nearest community: PEREMABIRI 5. State: BAYELSA 6. LGA: SOUTHERN UTAH
7. Type of Production facility/Installation: OIL PIPELINE
8. Asset owner/District: THE SHELL PETROLEUM DEVELOPMENT COMPANY OF NIGERIA LIMITED (SPDC) / PIPELINE

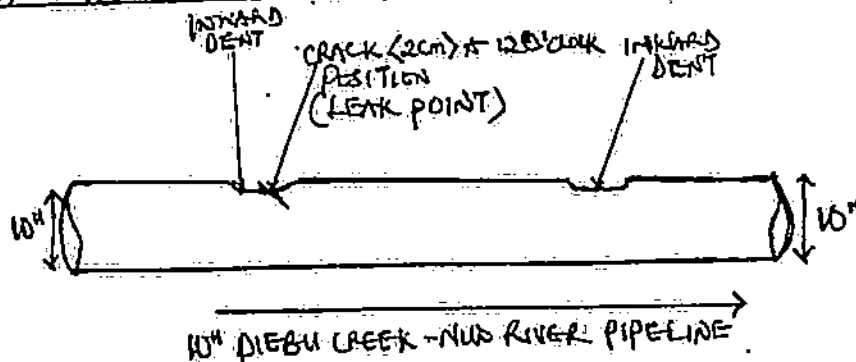
Additional observations around the spill point: THE JOINT INVESTIGATION TEAM OBSERVED A CRACK OF 2CM AND INWARD DENTS ALL AT 12 O'CLOCK POSITION OF 10th DIEBU CREEK - NUN RIVER PIPELINE

| <input type="checkbox"/> Corrosion | <input checked="" type="checkbox"/> Others (specify) <u>CRACK (2CM) AT 12 O'CLOCK POSITION</u> | |

SECTION OF 10" DIEBU CREEK - NUN RIVER PIPELINE AT PEREMABIRI SHOWING INWARD DENT AND A CRACK AT 12 O'CLOCK POSITION.

RECOVERY AND REPAIR ACTIVITIES ARE ONGOING
