JOINT INVESTIGATION REPORT

INCIDENT NO: 2293460 JIV report S/N: 0266

1. Spill incident Number: 2293460 2. Type of incident* OIL SPILL
3. Name of Location 16" TUNU-BRASS CREEK PIPELINE
4. Name of nearest community AGBIDIAMA 5. State: BAYELSA 6. LGA EKEREMOR
7. Type of Production facility/Installation OIL PIPELINE
8. Asset owner/District THE SHELL PETROLEUM DEVELOPMENT COMPANY OF NIGERIA LIMITED/PIPELINE

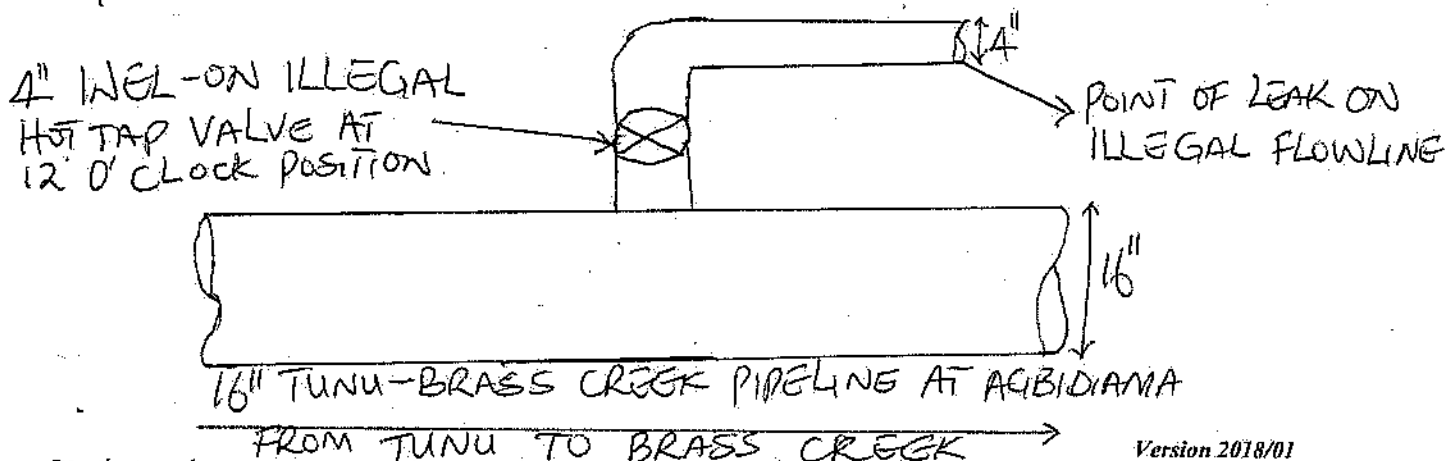
E. GRAPHIC DESCRIPTION OF LEAK POINT (while detailed report of the leak point should be contained in the leak report, overview sketch of the site should be added as an appendix 1) A SECTION OF 16" TUNU-BRASS CREEK PIP @ ACBIDIAMA SHOWING 4" WELDON ILLEGAL HOT-TAP VALVE AT 12 O'CLOCK POSITION INSTALLED BY UNKNOWN PERSONS.

RECOVERY OF CRUDE OIL AND REPAIR BY CLAMPING ARE ONGOING

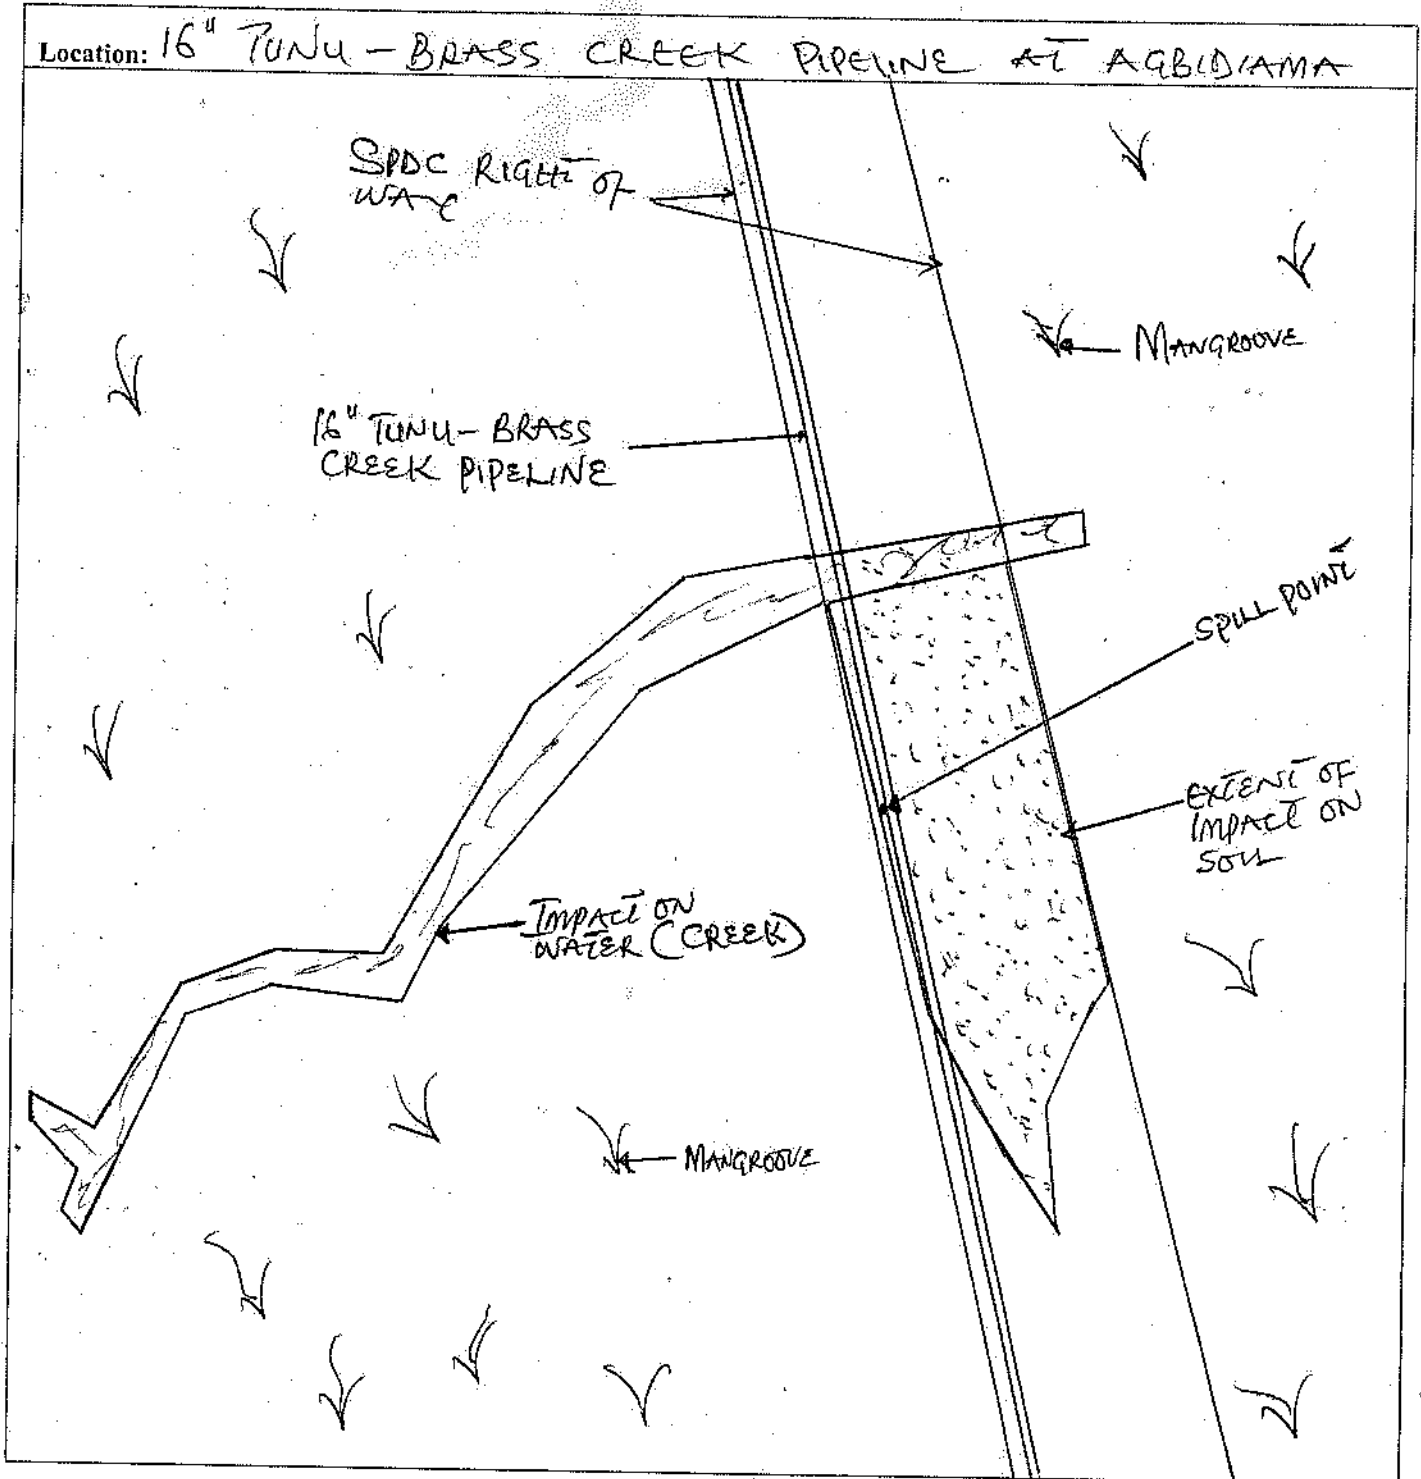
f. Appendix 1: Overview sketch of the site

- Total calculated area of impact 1.597 HA
- Impact within R.O.W YES
- Impact outside R.O.W YES
