# JOINT INVESTIGATION REPORT

INCIDENT NO: 2310600 JIV report S/N:0295

1. Spill incident Number: 2310600 2. Type of incident\*: OIL SPILL  
3. Name of Location: 28" NIKPOKU - BONNU PIPELINE  
4. Name of nearest community: B-DERE 5. State: RIVERS 6. LGA: GOLETA  
7. Type of Production facility/Installation: OIL PIPELINE  
8. Asset owner/District: THE SHELL PETROLEUM DEVELOPMENT COMPANY OF NIGERIA LIMITED / PIPELINE

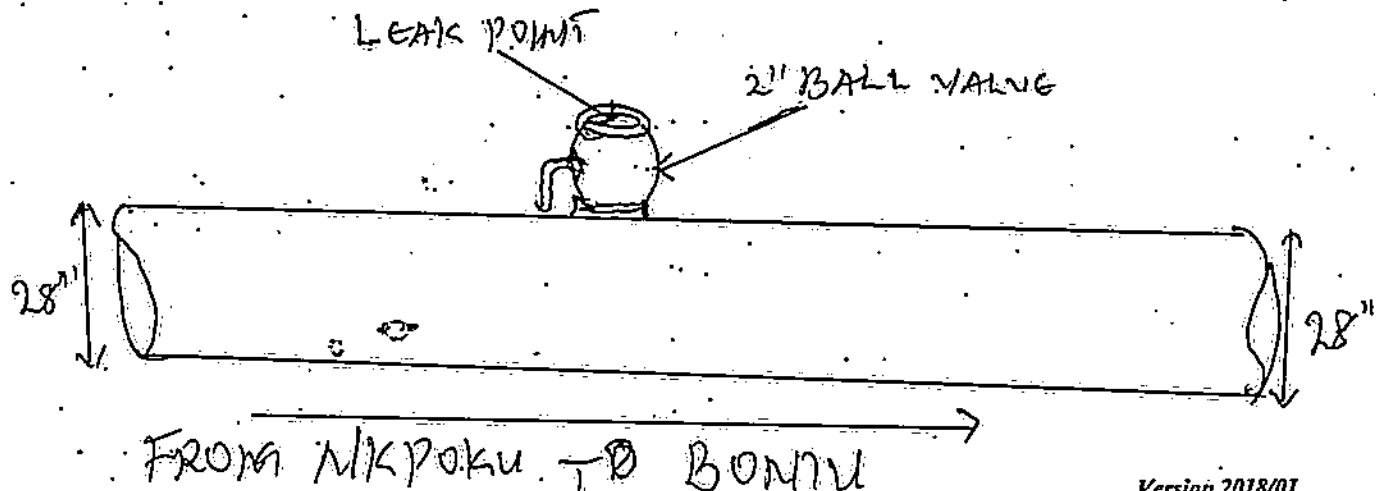
| <input checked="" type="checkbox"/> Failed Weld-on illegal hot tap valve | <input type="checkbox"/> Failed Clamp | <input type="checkbox"/> Missing Pipeline/Flowline |
| <input checked="" type="checkbox"/> Crude oil theft (illegal bunkering) point | <input type="checkbox"/> Saver-pit over flow | <input type="checkbox"/> Third party tampering with Clamp |

SECTION OF 28" MKPOKU - BONNI PIPELINE AT B-DERE SHOWING CRUDE OIL LEAK POINT AT 12 O'CLOCK POSITION.

REPAIR WORK WAS DONE BY CLAMPING.
