JOINT INVESTIGATION REPORT

INCIDENT NO: 2340867 JIV report S/N: 0241

- 1. Spill incident Number: 2340867 2. Type of incident*: OIL SPILL
- 3. Name of Location: 14th OKORDIA - KUMUEPE PIPELINE
- 4. Name of nearest community: SKALA - OLU 5. State: RIVERS 6. LGA: ASHADA - WEST
- 7. Type of Production facility/Installation: OIL PIPELINE
- 8. Asset owner/District: THE SHELL PETROLEUM DEVELOPMENT COMPANY OF NIGERIA LIMITED (SPDC) / PIPELINE

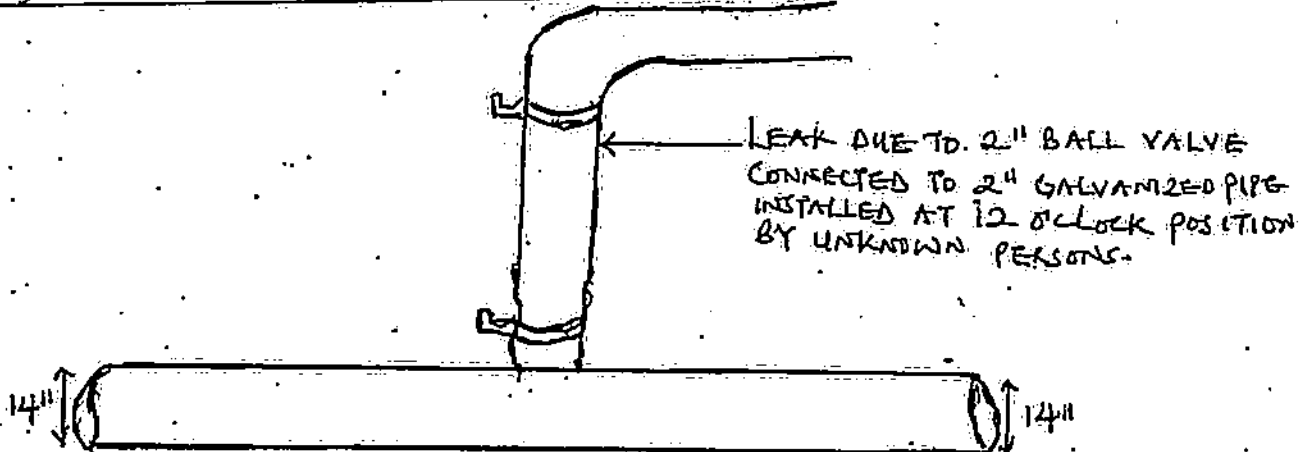
| <input checked="" type="checkbox"/> Failed Weld-on illegal hot tap valve | <input type="checkbox"/> Failed Clamp | <input type="checkbox"/> Missing Pipeline/Flowline |
| <input checked="" type="checkbox"/> Crude oil theft (illegal bunkering) point | <input type="checkbox"/> Saver-pit over flow | <input type="checkbox"/> Third party tampering with Clamp |

E. GRAPHIC DESCRIPTION OF LEAK POINT (while detailed report of the leak point should be contained in the leak report, overview sketch of the site should be added as an appendix 1) A SECTION OF 14" O.K.S.D.I.A =

RUMUKEPE PIPELINE AT AKALA-OLU SHOWING A 2" BALL VALVE CONNECTED TO 2" GALVANIZED PIPE ON 12 O'CLOCK POSITION BY UNKNOWN PERSONS.

RECOVERY AND REPAIR ACTIVITIES
