# JOINT INVESTIGATION REPORT

INCIDENT NO: 2340869 JIV report S/N: 0259

1. Spill incident Number: 2340869 2. Type of incident\*: OIL SPILL  
3. Name of Location: 14<sup>th</sup> OKORDIA - RUMUKEPE PIPELINE  
4. Name of nearest community: AKALA - OLU 5. State: RIVERS 6. LGA: AKHADA-WEST  
7. Type of Production facility/Installation: OIL PIPELINE  
8. Asset owner/District: THE SIGEL PETROLEUM DEVELOPMENT COMPANY OF NIGERIA LIMITED (SPDC) PIPELINE

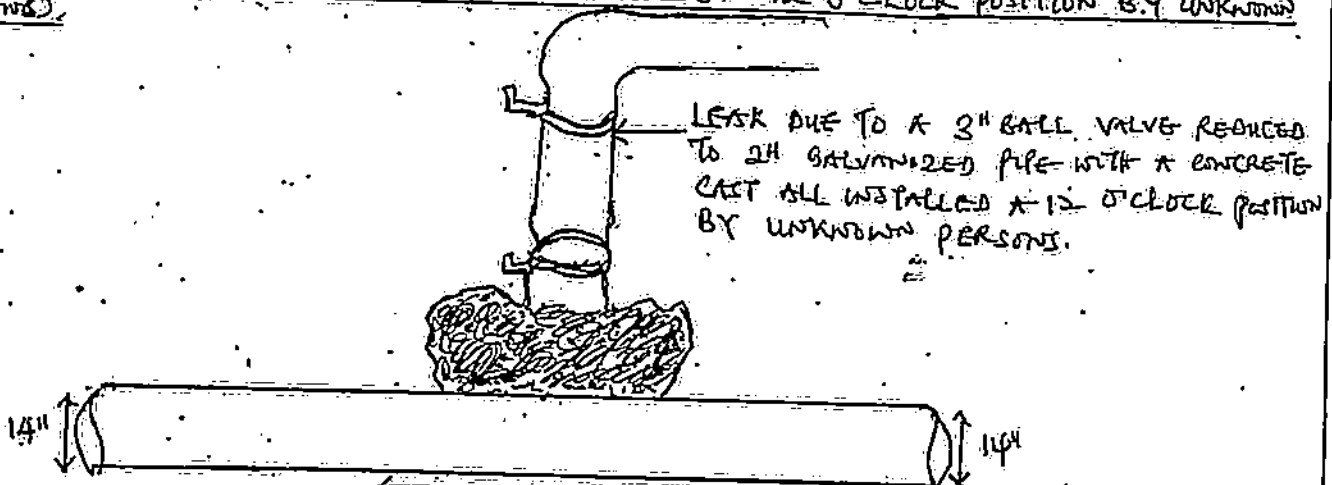
Additional observations around the spill point: THE JOINT INVESTIGATION TEAM OBSERVED A 2" BALL VALVE REDUCED TO 2" GALVANIZED PIPE WITH A CONCRETE-CAST INSTALLED AT 12 O'CLOCK POSITION BY UNKNOWN PERSONS.

**E. GRAPHIC DESCRIPTION OF LEAK POINT** (while detailed report of the leak point should be contained in the leak report, overview sketch of the site should be added as an appendix 1) A SECTION OF 14" OXFORDA - RUMUKEPE PIPELINE AT AKALA-OLU SHOWING A 3" BALL VALVE REDUCED TO 2" GALVANIZED PIPE WITH A CONCRETE-CAST ALL ON 12 O'CLOCK POSITION BY UNKNOWN PERSONS.

CRUDE OIL RECOVERY AND REPAIR ACTIVITIES ARE ONGOING
