# JOINT INVESTIGATION REPORT

INCIDENT NO: <sup>2341788</sup>~~2341788~~ JIV report S/N:0279

1. Spill incident Number: <sup>2341788</sup>~~2341788~~ 2. Type of incident\* OIL SPILL
3. Name of Location 24" BOMU - BONNY PIPELINE
4. Name of nearest community PATRICK WATER- SIDE (BODO) 5. State: RIVERS 6. LGA GOKANA
7. Type of Production facility/Installation OIL PIPELINE
8. Asset owner/District THE SHELL PETROLEUM DEVELOPMENT COMPANY OF NIGERIA LTD (SPDC) / PIPELINE

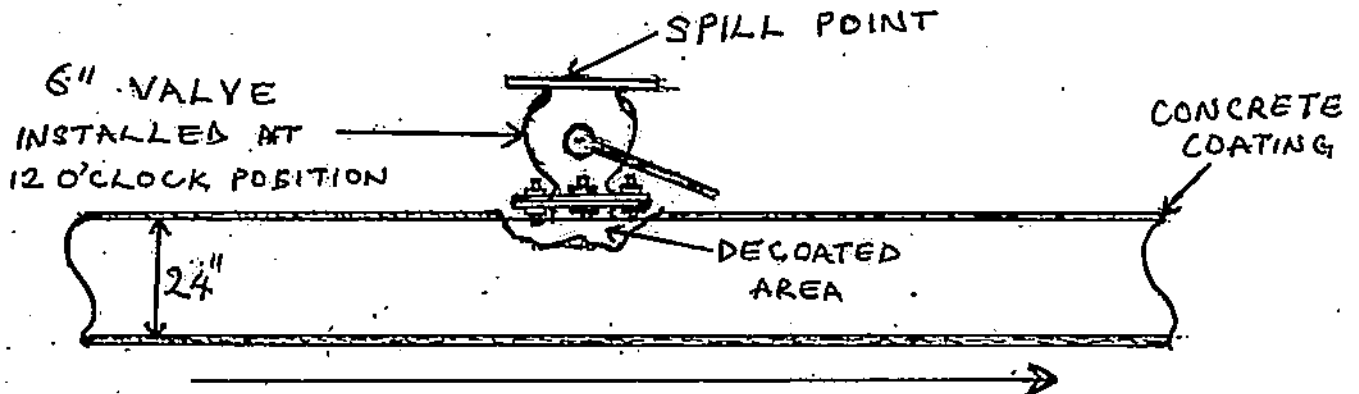
| <input checked="" type="checkbox"/> Crude oil theft (illegal bunkering) point | <input type="checkbox"/> Saver-pit over flow | <input type="checkbox"/> Third party tampering with Clamp |

**E. GRAPHIC DESCRIPTION OF LEAK POINT** (while detailed report of the leak point should be contained in the leak report, overview sketch of the site should be added as an appendix 1) A SECTION OF 24" BOMU-BONNY PIPELINE AT PATRICK WATER-SIDE (BODD) SHOWING 6" VALVE CRUDE THEFT POINT INSTALLED AT 12 O'CLOCK POSITION BY UNKNOWN PERSON(S).

REPAIR BY CLAMPING
