# JOINT INVESTIGATION REPORT

INCIDENT NO: 2347955 JIV report S/N: 0124

1. Spill incident Number: 2347955 2. Type of incident\*: OIL SPILL  
3. Name of Location: 28<sup>th</sup> BOMU - BONNY PIPELINE (TNP)  
4. Name of nearest community: OKOKIRI 5. State: RIVERS 6. LGA: ANDONI  
7. Type of Production facility/Installation: OIL PIPELINE  
8. Asset owner/District: THE SHELL PETROLEUM DEVELOPMENT COMPANY OF NIGERIA LIMITED (SPDC) / PIPELINE

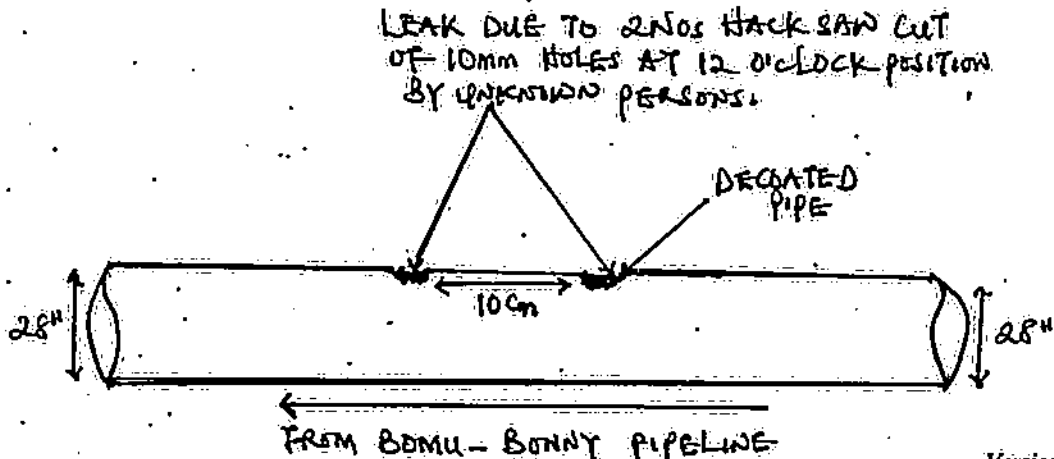
**E. GRAPHIC DESCRIPTION OF LEAK POINT** (while detailed report of the leak point should be contained in the leak report, overview sketch of the site should be added as an appendix 1) A SECTION OF 28" BONNY PIPELINE AT ONKOKI SHOWING 2 NOS HACK SAW CUT OF 10mm HOLES AT 12 O'CLOCK POSITION BY UNKNOWN PERSONS.
