JOINT INVESTIGATION REPORT

INCIDENT NO: 2348156 JIV report S/N: 0125

1. Spill incident Number: 2348156 2. Type of incident*: OIL SPILL
3. Name of Location: OBIGBO NORTH WELL 3 FLOWLINES (L/S)
4. Name of nearest community: UMUEBULU 5. State: RIVERS 6. LGA: ETCHE
7. Type of Production facility/Installation: FLOWLINE
8. Asset owner/District: THE SHELL PETROLEUM DEVELOPMENT COMPANY OF NIGERIA LIMITED (SPDC) / LAND EAST HUB

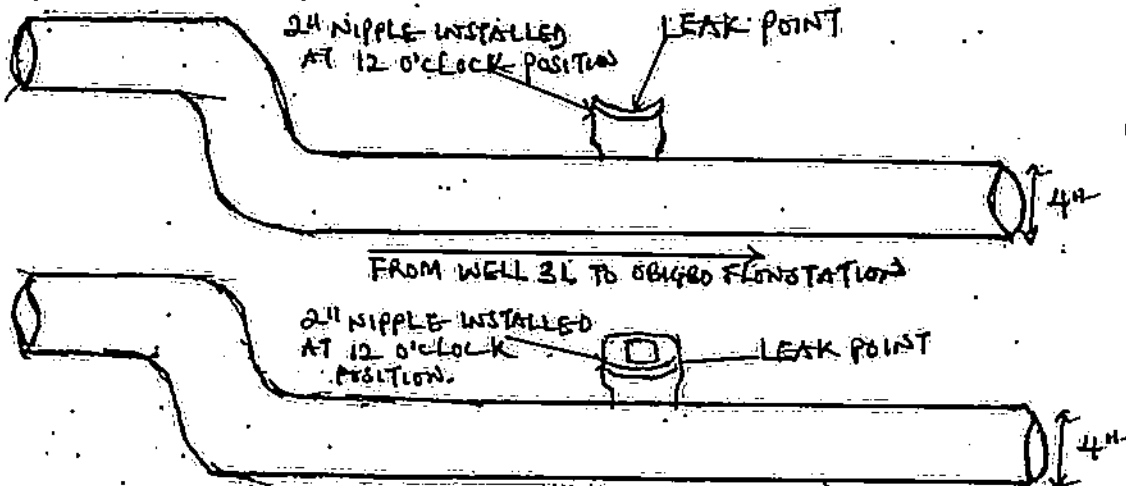
Additional observations around the spill point: THE JOINT INVESTIGATION TEAM OBSERVED 2ND 2^U NIPPLES INSTALLED AT 12 O'CLOCK POSITION BY UNKNOWN PERSONS ON THE OBIGBO NORTH WELL 3(a) AND (b) FLOWLINES AT UMUEBULU.

| <input checked="" type="checkbox"/> Crude oil theft (illegal bunkering) point | <input type="checkbox"/> Saver-pit over flow | <input type="checkbox"/> Third-party tampering with Clamp |

E. GRAPHIC DESCRIPTION OF LEAK POINT (while detailed report of the leak point should be contained in the leak report, overview sketch of the site should be added as an appendix 1) SECTIONAL VIEW OF OBIGBO NORTH WELL 3L(S) FLOWLINES AT UMUEBULU SHOWING 2 NOS 2" NIPPLES INSTALLED AT 12 O'CLOCK POSITION BY UNKNOWN PERSONS.

RECOVERY ACTIVITY AND PLANNED REPAIR BY SECTIONAL REPLACEMENT

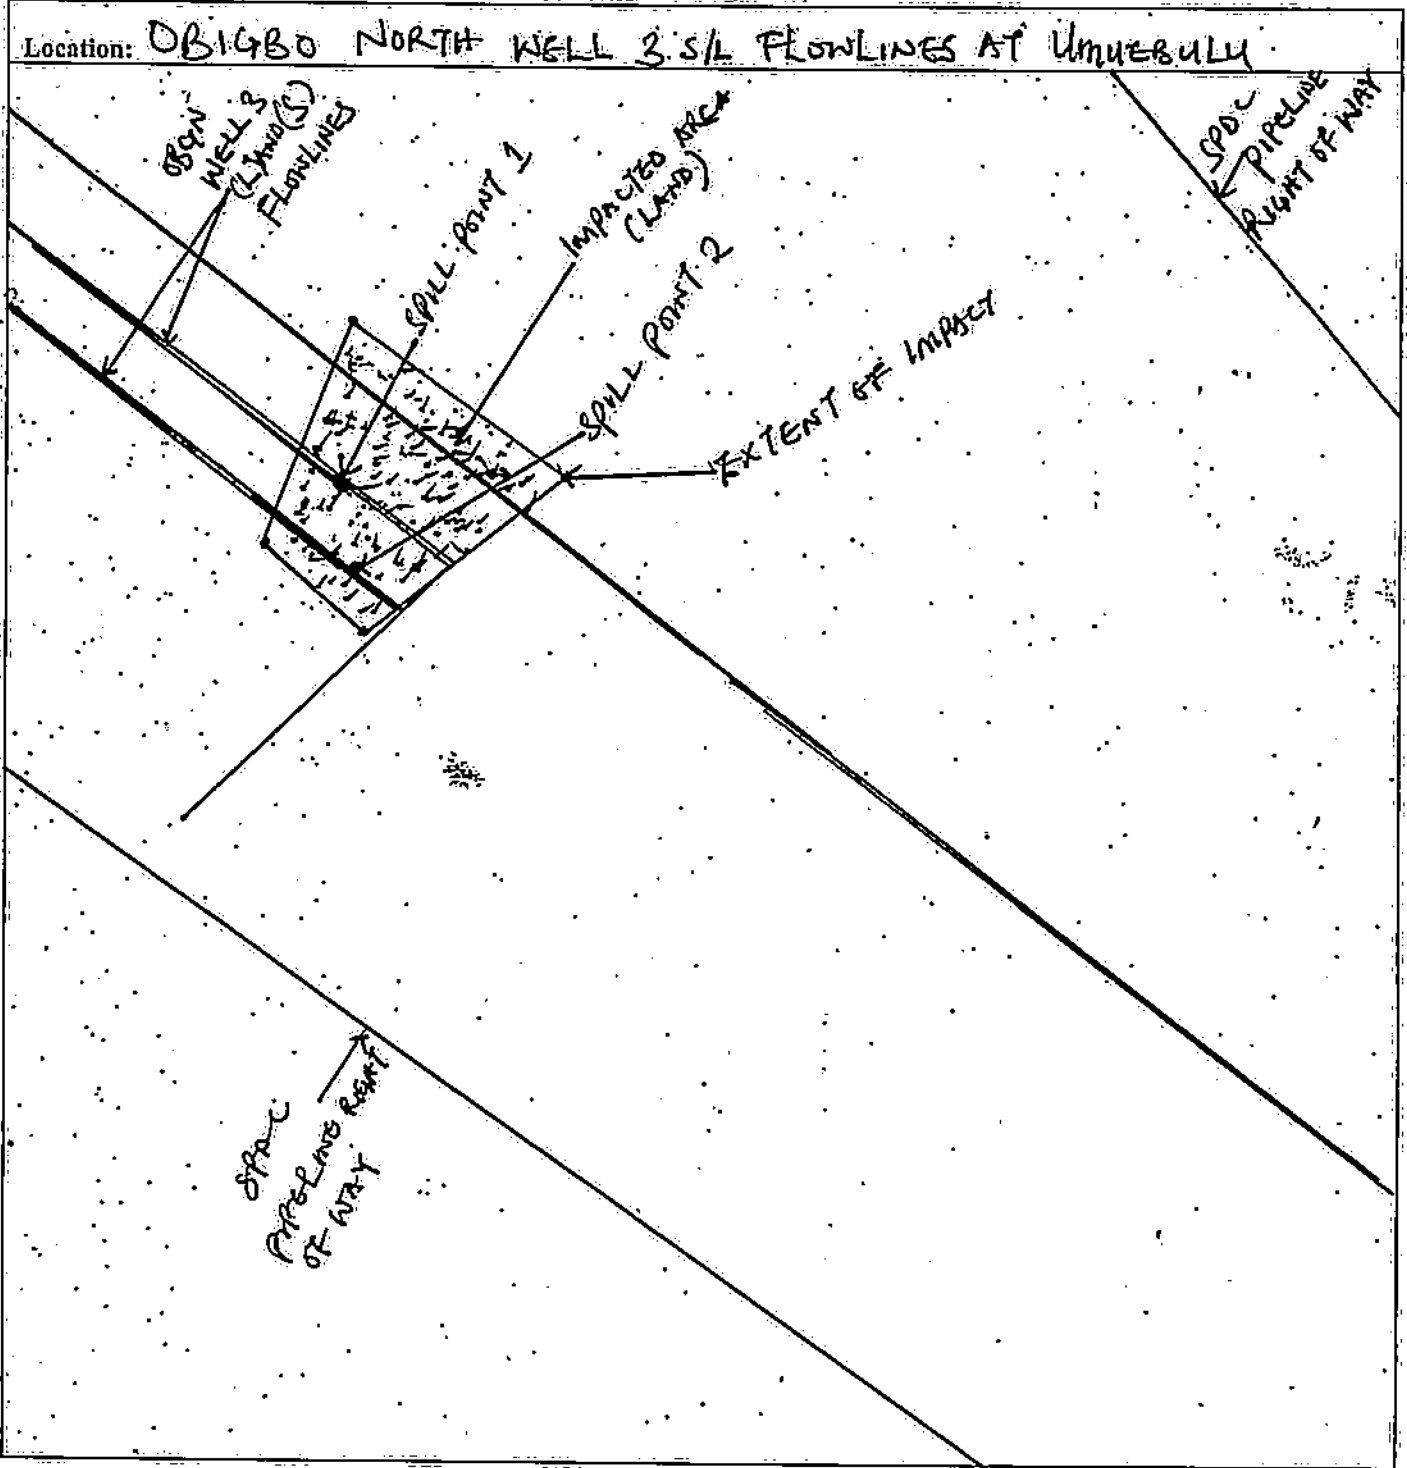
f. Appendix 1: Overview sketch of the site

- Total calculated area of impact 0.0013 HA.
- Impact within R.O.W YES
- Impact outside R.O.W NO
