JOINT INVESTIGATION REPORT

INCIDENT NO: 2349567 JIV report S/N: 0116

1. Spill incident Number: 2349567 2. Type of incident* OIL SPILL (CRUDE THEFT POINT)
3. Name of Location 20th KOLO CREEK - BUMUEKPE PIPELINE
4. Name of nearest community OKOMA - 1 5. State: RIVERS 6. LGA AHOADA EAST
7. Type of Production facility/Installation OIL PIPELINE

8. Asset owner/District SHELL PETROLEUM DEVELOPMENT COMPANY OF NIGERIA LIMITED
PIPELINE

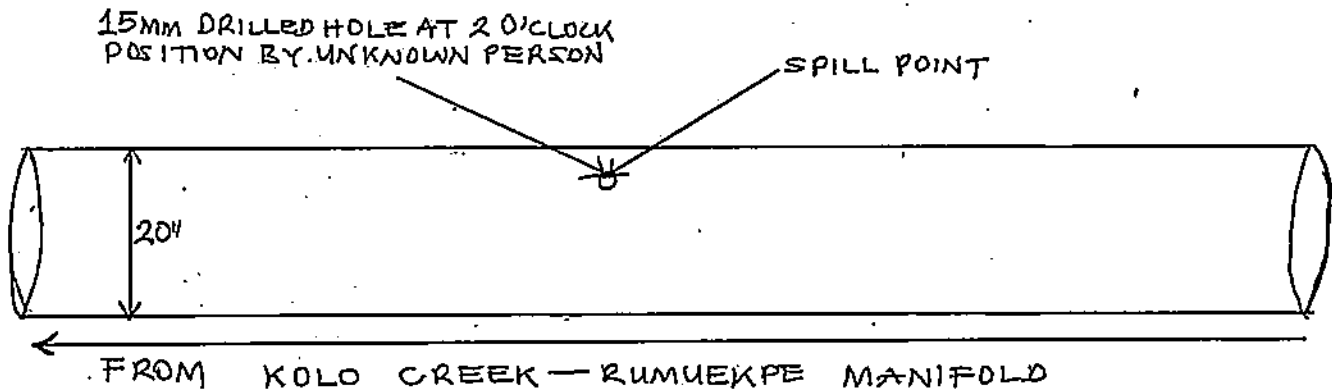
Additional observations around the spill point: THE JOINT INVESTIGATION TEAM OBSERVED A 15mm DRILLHOLE AT A 2 O'CLOCK POSITION.

E. GRAPHIC DESCRIPTION OF LEAK POINT (while detailed report of the leak point should be contained in the leak report, overview sketch of the site should be added as an appendix 1) A SECTION OF 20" KOLO CREEK - RUMUEKPE PIPELINE AT OKOMA SHOWING 15MM DRILLED HOLE AT 2 O'CLOCK POSITION BY UNKNOWN PERSONS.

REPAIR BY CLAMPING AND CRUDE OIL RECOVERY ON-GOING
