JOINT INVESTIGATION REPORT

INCIDENT NO: 2351813 JIV report S/N: 0139

1. Spill incident Number: 2351813 2. Type of incident*: OIL SPILL (CRUDE THEFT POINT)
3. Name of Location 20th KOLD CREEK - BUMUEKPE PIPELINE
4. Name of nearest community OKOMA - 1 5. State: RIVERS 6. LGA AHOADA EAST
7. Type of Production facility/Installation OIL PIPELINE
8. Asset owner/District SHELL PETROLEUM DEVELOPMENT COMPANY OF NIGERIA LIMITED / PIPELINE

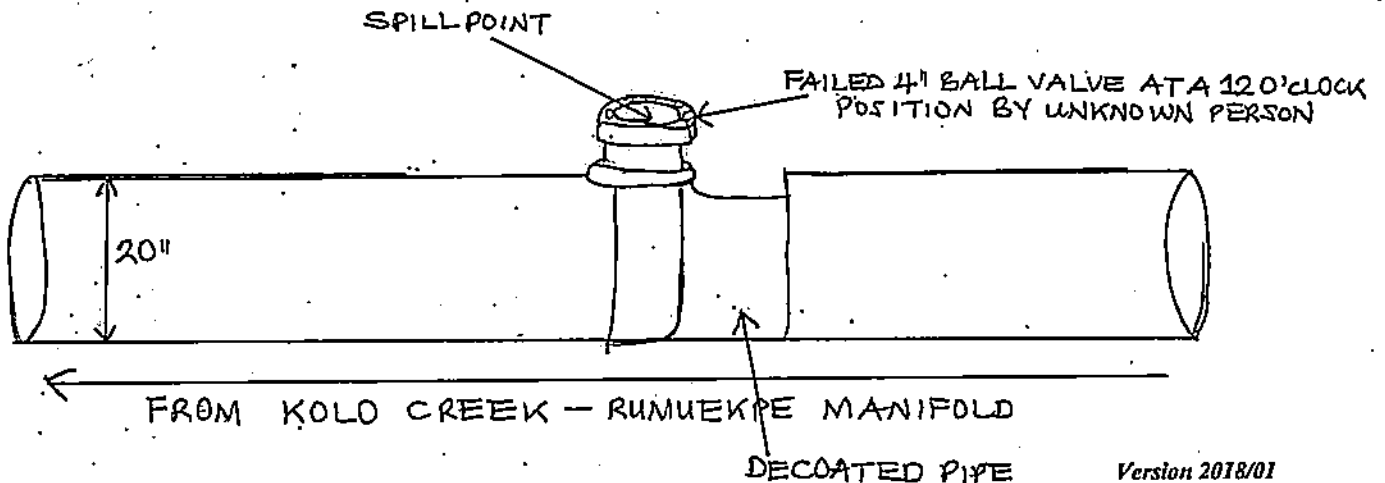
E. GRAPHIC DESCRIPTION OF LEAK POINT (while detailed report of the leak point should be contained in the leak report, overview sketch of the site should be added as an appendix 1) A SECTION OF 20" KOLD CREEK - RUMUEKPE PIPELINE AT OKOMA SHOWING FAILED 4" BALL VALVE POSITION BY UNKNOWN PERSONS.

REPAIR BY CLAMPING ON-GOING.
