# JOINT INVESTIGATION REPORT

INCIDENT NO: 2352367 JIV report S/N: 0114

1. Spill incident Number: 2352367 2. Type of incident\* OIL SPILL  
3. Name of Location 20" KOLOCREEK - RUMUEKPE PIPELINE  
4. Name of nearest community ODAU (KM9) State: RIVERS 6. LGA ABUA/ODUAL  
Production facility/Installation OIL PIPELINE

8. Asset owner/District THE SHELL PETROLEUM DEVELOPMENT COMPANY OF NIGERIA LIMITED / PIPELINE

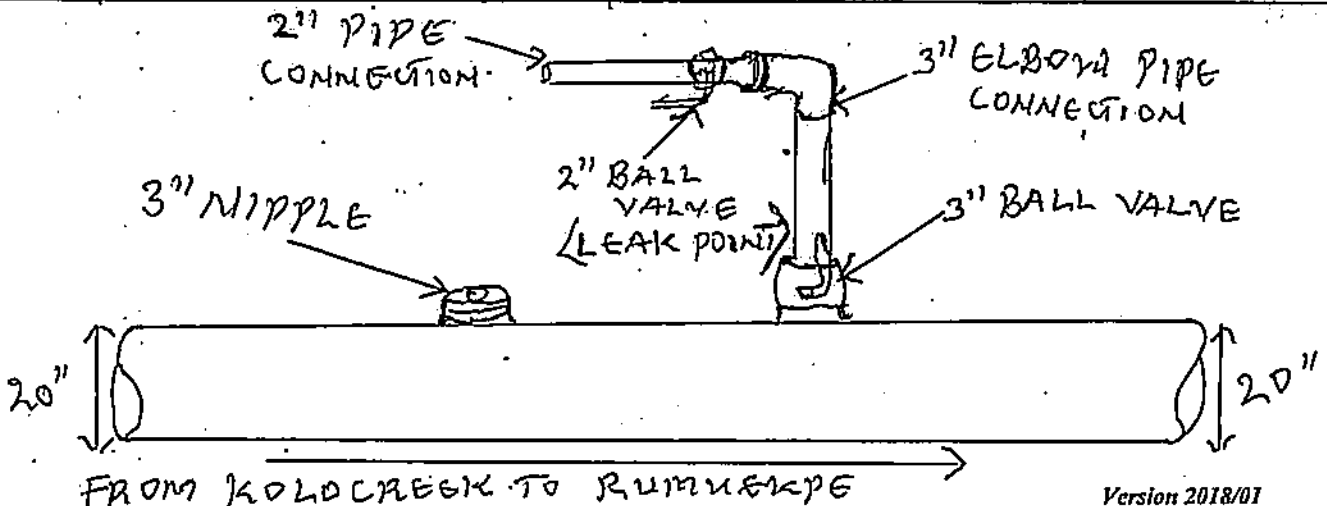
Additional observations around the spill point: THE JOINT INVESTIGATION TEAM OBSERVED 3" BALL VALVE AND 3" NIPPLE ILLEGALLY INSTALLED AT 12 O'CLOCK POSITION ON 20" KOLOCREEK - RUMUEKPE PIPELINE AT ODAU (KM9).

| <input checked="" type="checkbox"/> Crude oil theft (illegal bunkering) point | <input type="checkbox"/> Saver-pit over flow | <input type="checkbox"/> Third party tampering with Clamp |

SECTION OF 20" KOLOCREEK - RUMURUPE PIPELINE AT DIDAU (km 9) SHOWING CRUDE OIL LEAK POINTS AT 12 O'CLOCK POSITION.
