JOINT INVESTIGATION REPORT

INCIDENT NO: 2360346 JIV report S/N: 1030008

1. Fountain Incident Number: 2360346 2. Type of incident* OIL SPILL
3. Name of Location 4th OKORNA - RUMUKEPE TRUNKLINE (PIPELINE)
4. Name of nearest community OSHE 5. State: RIVERS 6. LGA ATIOTTA WEST
7. Type of Production facility/Installation OIL PIPELINE
8. Asset owner/District THE SHELL PETROLEUM DEVELOPMENT COMPANY OF NIGERIA LIMITED / PIPELINE

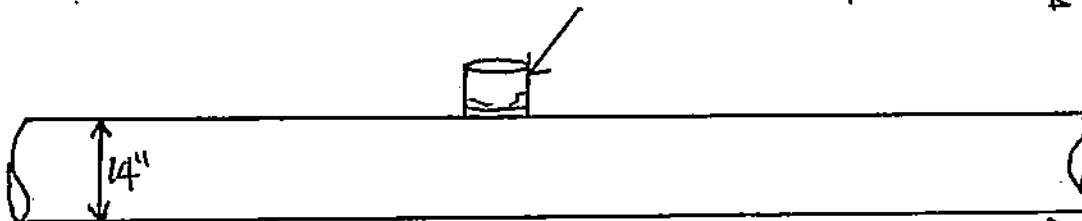
E. GRAPHIC DESCRIPTION OF LEAK POINT (while detail report of the leak point should be contained in the leak report, overview sketch of the site should be added as an appendix 1) A SECTION OF 14" OKORDIA - RUMUEKPE TRUNKLINE AT OSHI SHOWING 2" ILLEGAL CONNECTION INSTALLED AT 12 O'CLOCK POSITION BY UNKNOWN PERSONS.

LEAK DUE TO 2" ILLEGAL CONNECTION INSTALLED AT 12 O'CLOCK POSITION BY UNKNOWN PERSONS

REPAIR BY CLAMPING ONGOING
