JOINT INVESTIGATION REPORT

INCIDENT NO: 2360398 JIV report S/N: 1030004

1. Fountain Incident Number: 2360398 2. Type of incident* OIL SPILL
3. Name of Location 14th OKORDIA - RUMUEKPE TRUNK LINE (PIPELINE)
4. Name of nearest community OSHIE 5. State: RIVERS 6. LGA: AHOADA WEST
7. Type of Production facility/Installation OIL PIPELINE
8. Asset owner/District THE SHELL PETROLEUM DEVELOPMENT COMPANY OF NIGERIA LIMITED / PIPELINE

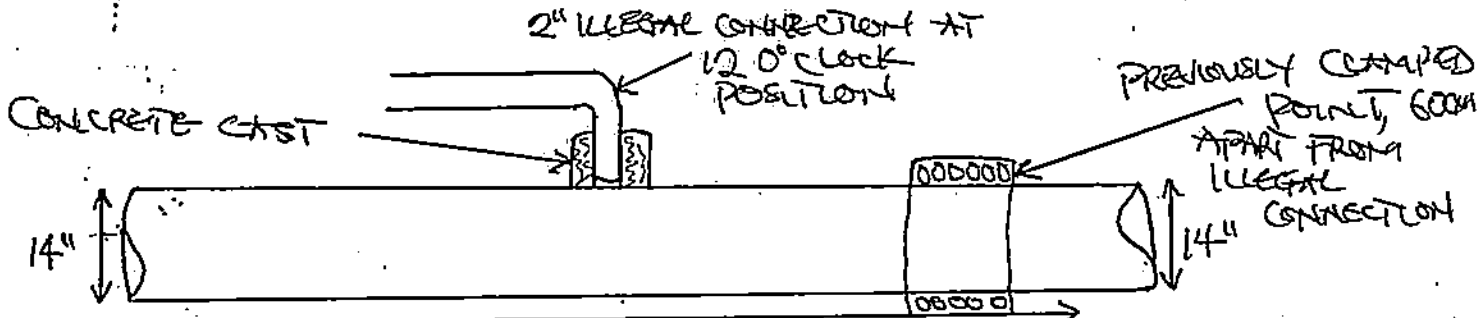
Additional observations around the spill point: THE JOINT INVESTIGATION TEAM OBSERVED EVIDENCE OF BURNT AREA DUE TO ILLEGAL BUNKERING ACTIVITIES.

E. GRAPHIC DESCRIPTION OF LEAK POINT (while detail report of the leak point should be contained in the leak report, overview sketch of the site should be added as an appendix 1) A SECTION OF 14" OKORDIA RUMUEKPE TRUNKLINE AT OSHIE SHOWING A 2" ILLEGAL CONNECTION INSTALLED AT 12 O'CLOCK POSITION BY UNKNOWN PERSONS

REPAIR BY CLAMPING ONGOING
