# JOINT INVESTIGATION REPORT

INCIDENT NO: 2342673 JIV report S/N: 0131

- 1. Spill incident Number: 2342673      2. Type of incident\*: OIL SPILL
- 3. Name of Location 4<sup>th</sup> OPUKUSHI WELL 9T FLOWLINE
- 4. Name of nearest community EGBEMO-ANLAGIKI      5. State: BAYELSA 6. LGA EKEREMOR
- 7. Type of Production facility/Installation OIL FLOWLINE
- 8. Asset owner/District THE SHELL PETROLEUM DEVELOPMENT COMPANY OF NIGERIA LIMITED

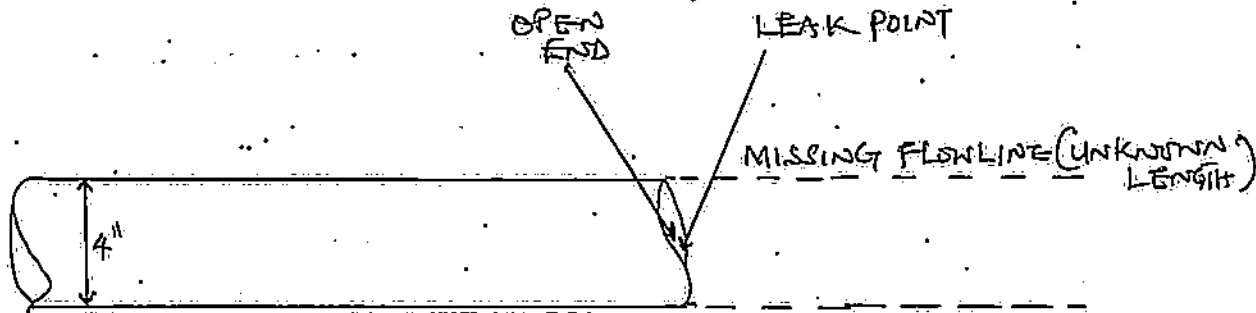
**E. GRAPHIC DESCRIPTION OF LEAK POINT** (while detailed report of the leak point should be contained in the leak report, overview sketch of the site should be added as an appendix 1) A SECTION OF 4" OPUKUSHI WELL 9T FRONTLINE AT AGBIDIAMA SHOWING MISSING FLOWLINE (THEFT) BY UNKNOWN PERSONS

From WELL 9T TO OPUKUSHI FLOWSTATION
