JOINT INVESTIGATION REPORT

INCIDENT NO: 2344331 JIV report S/N: 0129

1. Spill incident Number: 2344331 2. Type of incident*: OIL SPILL
3. Name of Location: 4" OPUKUSHI WELL 24T FLOWLINE
EGBEND ANZLABIRI
4. Name of nearest community AGBIDIANA 5. State: BAYELSA 6. LGA EKEREMOR
7. Type of Production facility/Installation OIL FLOWLINE
8. Asset owner/District THE SHELL PETROLEUM DEVELOPMENT COMPANY OF NIGERIA LIMITED (SPDC)

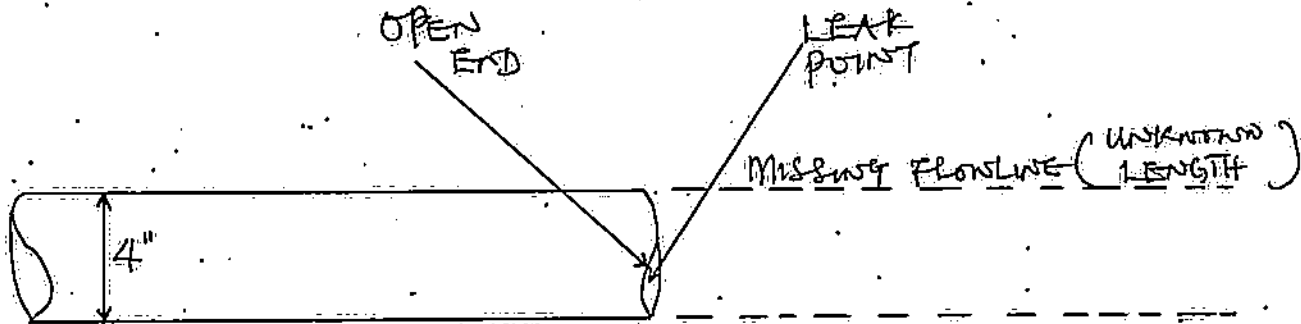
A SECTION OF 4" OPUKUSHI WELL 24T FLOWING AT AGBIDAMA SHOWING A MISSING FLOWLINE (THEFT)

FROM WELL 24T TO OPUKUSHI FLOWSTATION
