JOINT INVESTIGATION REPORT

INCIDENT NO: 2359133 JIV report S/N: 0121

1. Spill incident Number: 2359133 2. Type of incident*: OIL SPILL
3. Name of Location 12" IMO RIVER - OGALE PIPELINE
4. Name of nearest community UMUOLOLO 5. State: ABIA 6. LGA UKWA-WEST
7. Type of Production facility/Installation OIL PIPELINE
8. Asset owner/District THE SHELL PETROLEUM DEVELOPMENT COMPANY OF NIGERIA LIMITED (SPDC)/PIPELINE

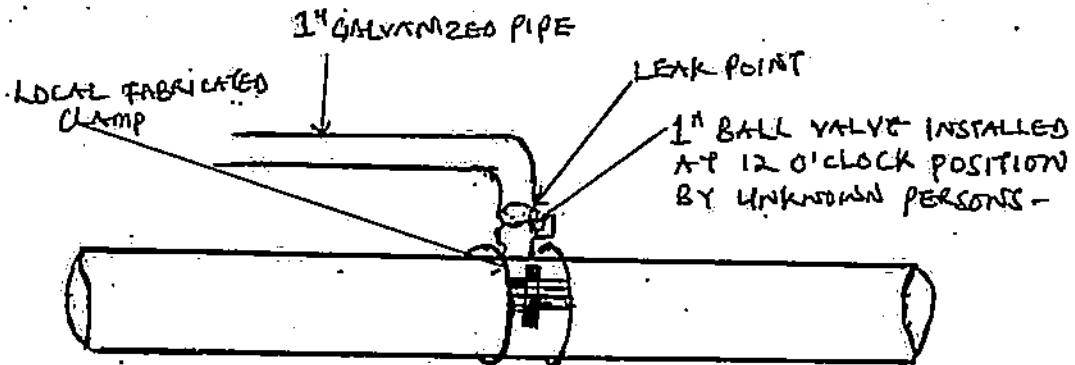
Additional observations around the spill point: THE JOINT INVESTIGATION TEAM OBSERVED A 1" BALL VALVE ATTACHED TO A LOCAL FABRICATED CLAMP WITH A 1" GALVANIZED PIPE ALL INSTALLED AT 12 O'CLOCK POSITION BY UNKNOWN PERSONS.

| <input checked="" type="checkbox"/> Failed Weld-on illegal hot tap valve | <input type="checkbox"/> Failed Clamp | <input type="checkbox"/> Missing Pipeline/Flowline |
| <input checked="" type="checkbox"/> Crude oil theft (illegal bunkering) point | <input type="checkbox"/> Saver-pit over flow | <input type="checkbox"/> Third party tampering with Clamp |

A SECTION OF 12" IMDRIVER-GALE PIPELINE AT UMUOLD SHOWING A 1" BALL VALVE ATTACHED TO A LOCAL FABRICATED CLAMP WITH A 1" GALVANIZED PIPE ALL INSTALLED AT 12 O'CLOCK POSITION BY UNKNOWN PERSONS.

FROM IMDRIVER - GALE PIPELINE

REPAIR BY CLAMPING
