JOINT INVESTIGATION REPORT

INCIDENT NO: 2343479 JIV report S/N: 0143

1. Spill incident Number: 2019-2343479 2. Type of incident* OIL SPILL
3. Name of Location YOKRI-LP1 BULKLINE MANIFOLD 8
4. Name of nearest community YOKRI 5. State: DELTA 6. LGA BURUTU
7. Type of Production facility/Installation MANIFOLD
8. Asset owner/District THE SHELL PETROLEUM DEVELOPMENT COMPANY OF NIGERIA

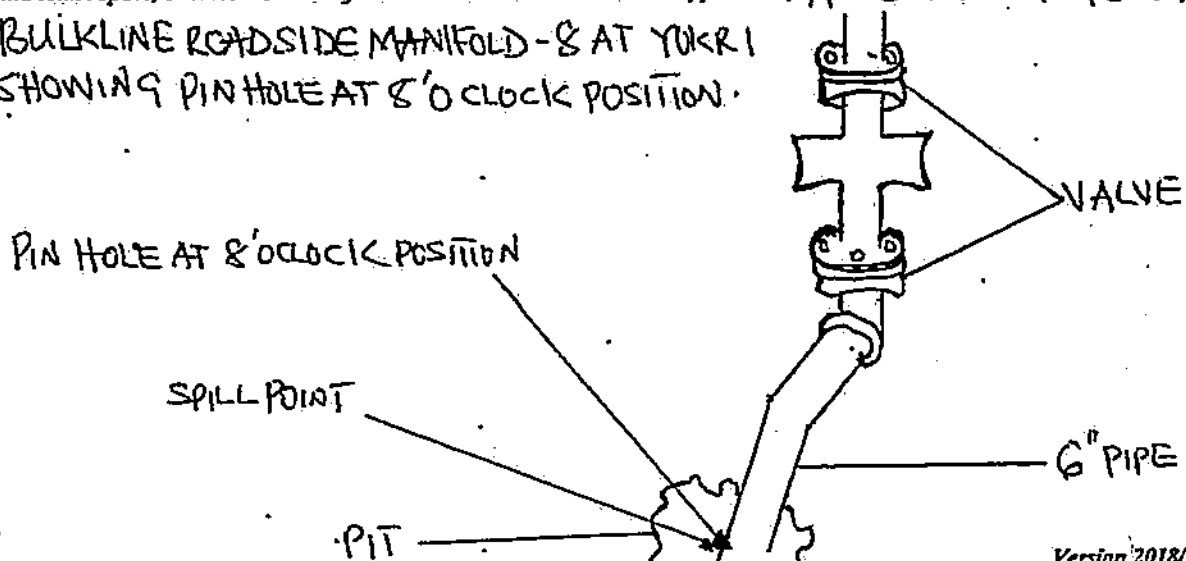
Additional observations around the spill point: THE JOINT INVESTIGATION TEAM OBSERVED A PIN HOLE AS A RESULT OF CORROSION AT 8 O'CLOCK.

E. GRAPHIC DESCRIPTION OF LEAK POINT (while detailed report of the leak point should be contained in the leak report, overview sketch of the site should be added as an appendix 1) **A SECTION OF YOKRI LP 1 BULKLINE ROADSIDE MANIFOLD - 8 AT YOKRI SHOWING PIN HOLE AT 8'O CLOCK POSITION.**

REPAIR ACTIVITY ONGOING
