JOINT INVESTIGATION REPORT

INCIDENT NO: 2364000 JIV report S/N: 1030025

1. Fountain Incident Number: 2364000 2. Type of incident* OIL SPILL
3. Name of Location 12th OGUTA - EGBEMA DELIVERY LINE
4. Name of nearest community UMUNKIWI 5. State: IMO 6. LGA OGUTA
7. Type of Production facility/Installation OIL PIPELINE
8. Asset owner/District THE SHELL PETROLEUM DEVELOPMENT COMPANY OF NIGERIA LIMITED (SPDC)/PIPELINES

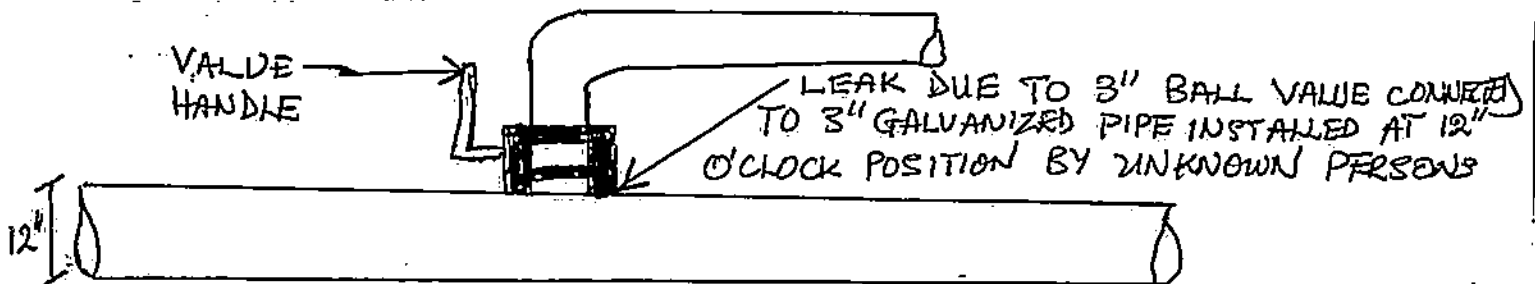
| <input checked="" type="checkbox"/> Failed Weld-on illegal hot tap valve | <input type="checkbox"/> Failed Clamp, | <input type="checkbox"/> Missing Pipeline/Flowline |
| <input checked="" type="checkbox"/> Crude oil theft (illegal bunkering) point, | <input type="checkbox"/> Saver-pit over flow | <input type="checkbox"/> Third party tampering with Clamp |

E. GRAPHIC DESCRIPTION OF LEAK POINT (while detail report of the leak point should be contained in the leak report, overview sketch of the site should be added as an appendix 1) A SECTION OF 12" OGUTA - EGBEMA PIPELINE AT UMUNKWU SHOWING A 3" BALL VALVE CONNECTED TO 3" GALVANIZED PIPE AT 12" O'CLOCK POSITION BY UNKNOWN PERSON

FROM OGUTA - EGBEMA PIPELINE
