# JOINT INVESTIGATION REPORT

INCIDENT NO: 2360591 JIV report S/N:0278

1. Spill incident Number: 2360591 2. Type of incident\*: OIL SPILL  
3. Name of Location 28" BOMU - BONNY PIPELINE  
4. Name of nearest community OWOKIRI 5. State: RIVERS 6. LGA ANDONI  
7. Type of Production facility/Installation OIL PIPELINE  
8. Asset owner/District THE SHELL PETROLEUM DEVELOPMENT COMPANY OF NIGERIA LTD (SPDC) / PIPELINE

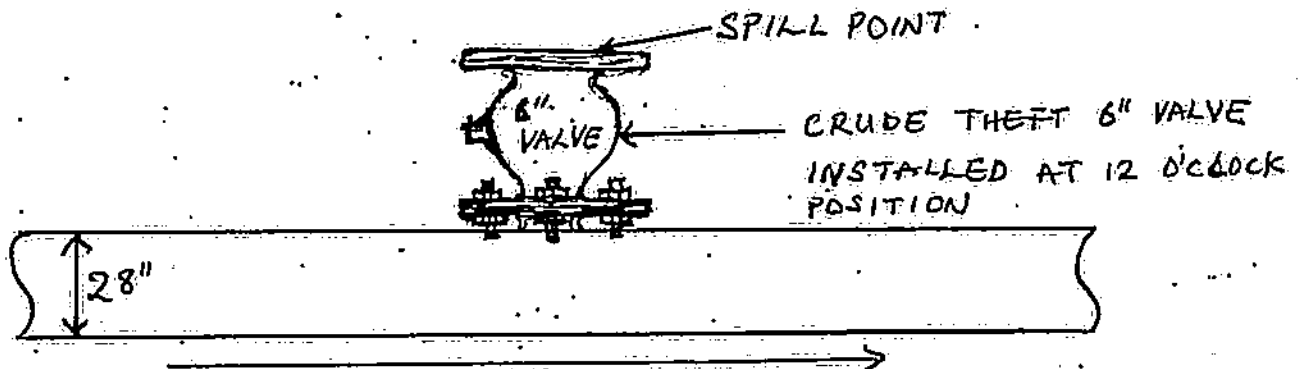
| <input checked="" type="checkbox"/> Crude oil theft (illegal bunkering) point | <input type="checkbox"/> Saver-pit over flow | <input type="checkbox"/> Third party tampering with Clamp |

**E. GRAPHIC DESCRIPTION OF LEAK POINT** (while detailed report of the leak point should be contained in the leak report, overview sketch of the site should be added as an appendix 1) **A SECTION OF 28" BOMU - BONNY PIPELINE AT OWOKIRI SHOWING 6" VALVE CRUDE THEFT POINT INSTALLED AT 12 O'CLOCK POSITION BY UNKNOWN PERSONS.**

REPAIR BY CLAMPING
