JOINT INVESTIGATION REPORT

INCIDENT NO: 234 6223 JIV report S/N: 0132

1. Spill incident Number: 234 6223 2. Type of incident*: OIL SPILL
3. Name of Location 8th OPUKUSHI WELL 25:1 FLOWLINE
EGBEMO-ANGALABIRI
4. Name of nearest community B. AGBIDIAMA 5. State: BAYELSA 6. LGA EKEREMOK
7. Type of Production facility/Installation OIL FLOWLINE
8. Asset owner/District THE SHELL PETROLEUM DEVELOPMENT COMPANY OF NIGERIA LIMITED / PIPELINE

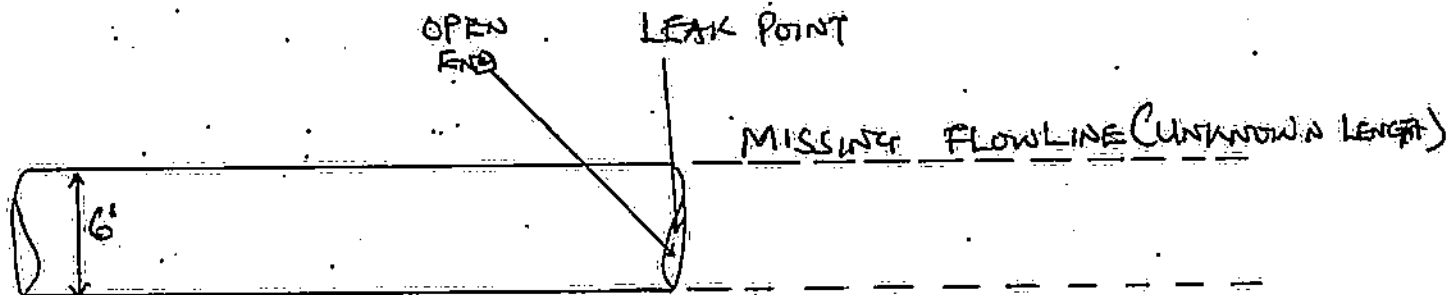
| <input type="checkbox"/> Failed Weld-on illegal hot tap valve | <input type="checkbox"/> Failed Clamp | <input checked="" type="checkbox"/> Missing Pipeline/Flowline |

E. GRAPHIC DESCRIPTION OF LEAK POINT (while detailed report of the leak point should be contained in the leak report, overview sketch of the site should be added as an appendix 1) A SECTION OF 6"

OPUKUSHI WELL 2ST FLOWLINE AT EGBEMO-ANALABIRI, SHOWING THE POINT WHERE IT WAS CUT-OFF AND FLOWLINE TAKEN AWAY
