JOINT INVESTIGATION REPORT

INCIDENT NO: 2360666 JIV report S/N: 0123

1. Spill incident Number: 2360666 2. Type of incident*: OIL SPILL
3. Name of Location 12th IMO RIVER - OGALE PIPELINE
4. Name of nearest community IGIRIUKWU (OWAZA) 5. State: ABIA 6. LGA UKWA-WEST
7. Type of Production facility/Installation OIL PIPELINE
8. Asset owner/District THE SHELL PETROLEUM DEVELOPMENT COMPANY OF NIGERIA LIMITED (SPDC) PIPELINE

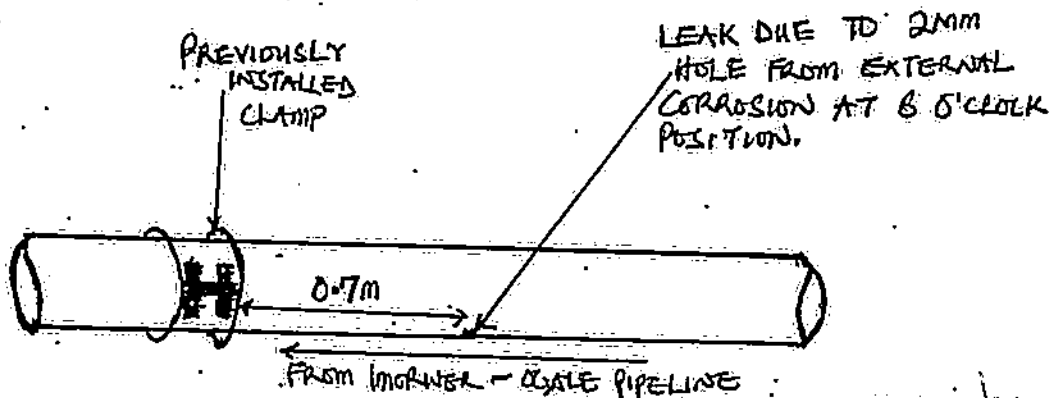
| <input checked="" type="checkbox"/> Corrosion | <input type="checkbox"/> Others(specify) _____ | |

E. GRAPHIC DESCRIPTION OF LEAK POINT (while detailed report of the leak point should be contained in the leak report, overview sketch of the site should be added as an appendix 1) A SECTION OF 12" IMPD RIVER - OYALE PIPELINE AT IGIRUKWU - OYAZA SHOWING A 2mm HOLE FROM EXTERNAL CORROSION AT SIX (6) O'CLOCK POSITION AND A PREVIOUSLY INSTALLED CLAMP.
