JOINT INVESTIGATION REPORT

INCIDENT NO: 2354264 JIV report S/N: 1030062

1. Fountain Incident Number: 2354264 2. Type of incident: OIL SPILL (LEAKING)
3. Name of Location: 20" OTUMARA-ESCRAVOS PIPELINE
4. Name of nearest community: UGBOEGUNGUN 5. State: DELTA 6. LGA: WARKI SOUTH-WEST
7. Type of Production facility/Installation: OIL PIPELINE
8. Asset owner/District: THE SHELL PETROLEUM DEVELOPMENT COMPANY OF NIGERIA

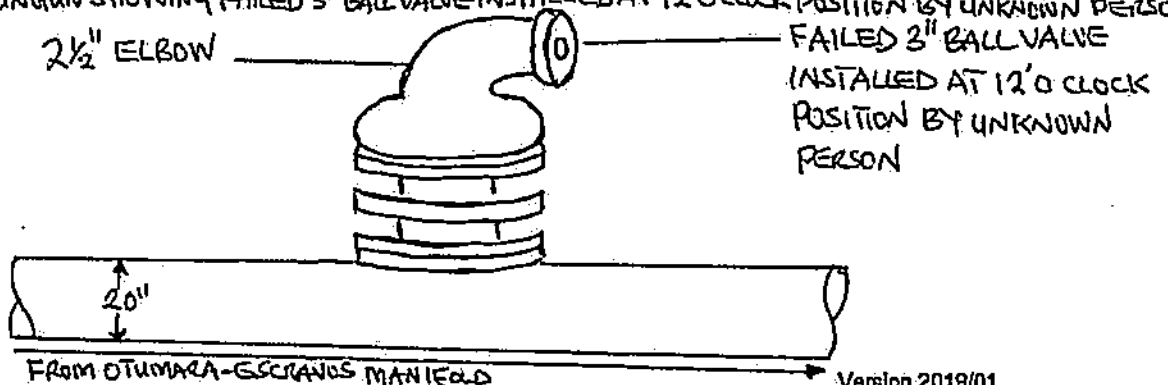
E. GRAPHIC DESCRIPTION OF LEAK POINT (while detail report of the leak point should be contained in the

Additional observations around the spill point: THE JOINT INVESTIGATION TEAM OBSERVED 3" VALVE (LEAKING) WITH 2 1/2" ELBOW PIPE CONNECTED ON THE 20" OTUMARA-ESCRAVOS PIPELINE. THIS INCIDENT WAS EARLIER REPORTED AS A NON-LEAKING INCIDENT (INCIDENT NO 2298604).

leak report, overview sketch of the site should be added as an appendix 1) A SECTION OF 20" OTUMARA-ESCRIVAS PIPELINE AT UGBOEGUNGUN SHOWING FAILED 3" BALL VALVE INSTALLED AT 12 O'CLOCK POSITION BY UNKNOWN PERSON.

BLIND FLANGING THE VALVE ONGOING
