JOINT INVESTIGATION REPORT

INCIDENT NO: 2497225 JIV report S/N: 1030078

1. Mountain Incident Number: 2497225 2. Type of incident: OIL SPILL
3. Name of Location: 20" TRANS - ESCRANOS PIPELINE
4. Name of nearest community: UGBOEGUNG State: DELTA Local Authority: IGBA WARRI SOUTH WEST
7. Type of Production facility/Installation: OIL PIPELINE
8. Asset owner/District: THE SHELL PETROLEUM DEVELOPMENT COMPANY / PIPELINE

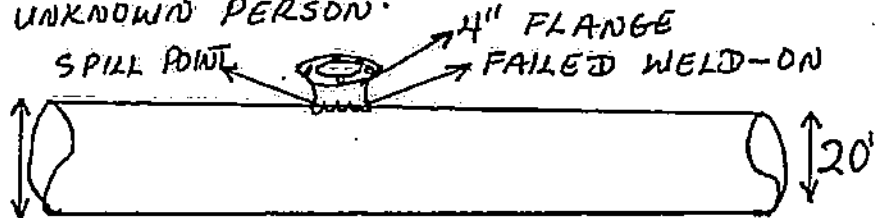
A SECTION OF 20" TRANS-ESCAUDS PIPELINE AT OGBOEGUNGUN SHOWING A FAILED WELD-ON 4" FLANGE INSTALLED AT 12 O'CLOCK POSITION BY UNKNOWN PERSON.

FROM OTUMARA - ESCRAUDS MANIFOLD
