JOINT INVESTIGATION REPORT

INCIDENT NO: 2500137 JIV report S/N: 1030167

1. Fountain Incident Number: 2500137 2. Type of incident* OIL SPILL
3. Name of Location: 8" ISIRI-IMO GATE DELIVERY LINE
4. Name of nearest community UZUAKU 5. State: ABIA 6. LGA UKWA WEST
7. Type of Production facility/Installation OIL PIPE LINE
8. Asset owner/District THE SHELL PETROLEUM DEVELOPMENT COMPANY OF NIGERIA LIMITED (SPDC) / PIPELINE

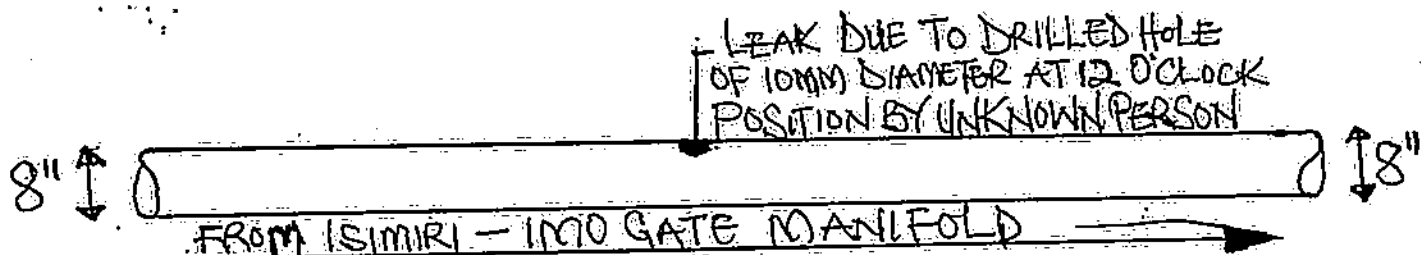
| <input checked="" type="checkbox"/> Drilled hole | <input type="checkbox"/> Hack saw cut | <input type="checkbox"/> Tear (_____) |

- Third party interference (Sabotage ; crude theft ; Line theft ; Accidental 3rd party damage
 Operational Others (including Mystery spills) _____

E. GRAPHIC DESCRIPTION OF LEAK POINT (while detail report of the leak point should be contained in the leak report, overview sketch of the site should be added as an appendix 1) A SECTION OF 8" SIMIRI-IMO GATE MANIFOLD DELIVERY LINE AT UZUAKU SHOWING 10MM DRILLED HOLE AT 12 O'CLOCK POSITION BY UNKNOWN PERSON.

CLAMPING ACTIVITY IN PROGRESS & EVACUATION
OF FREE PHASE CRUDE OIL
