JOINT INVESTIGATION REPORT

INCIDENT NO: 2502386 JIV report S/N: 1030079

1. Fountain Incident Number: 2502386 2. Type of incident* OIL SPILL
3. Name of Location 20" TRANS - ESCRAVOS PIPELINE
4. Name of nearest community UGBOEGUNGUN. State: DELTA 6. LGA WARRI SOUTH WEST
7. Type of Production facility/Installation OIL PIPELINE
8. Asset owner/District SHELL PETROLEUM DEVELOPMENT COMPANY OF NIGERIA LIMITED / PIPELINE.

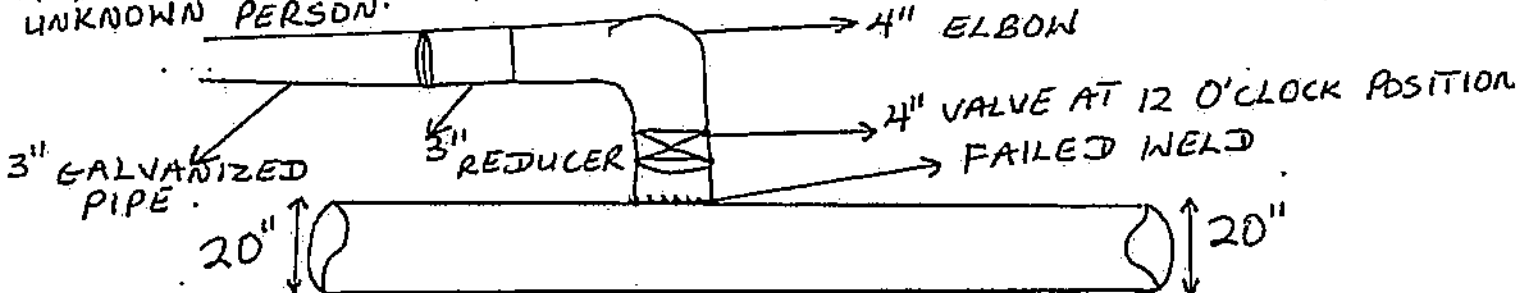
A SECTION OF 20" TRANS-ESCRANDS PIPELINE AT OGBOEGUNGUN SHOWING A FAILED WELD-ON 4" VALVE INSTALLED AT 12 O'CLOCK POSITION BY UNKNOWN PERSON.

FROM OTUMARA - ESCRANDS MAINLINE
