# JOINT INVESTIGATION REPORT

INCIDENT NO: 2504722 JIV report S/N: 1030172

1. Fountain Incident Number: 2504722 2. Type of incident\* OIL SPILL  
3. Name of Location 24<sup>th</sup> TNP ROW AT NONWA (NKPOKU-BOMU PIPELINE)  
4. Name of nearest community NONWA 5. State: RIVERS 6. LGA TAI  
7. Type of Production facility/Installation OIL PIPELINE  
8. Asset owner/District THE SHELL PETROLEUM DEVELOPMENT COMPANY OF NIGERIA LIMITED (SPDC) / PIPELINE

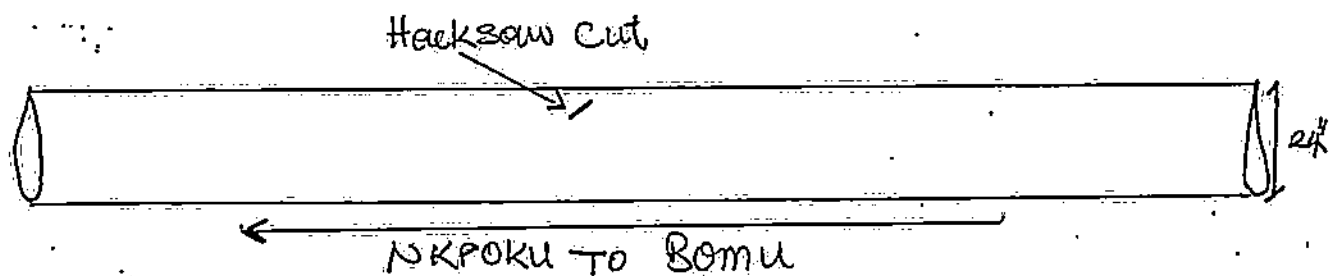
| <input type="checkbox"/> Drilled hole | <input checked="" type="checkbox"/> Hack saw cut | <input type="checkbox"/> Tear (_____) |

**E. GRAPHIC DESCRIPTION OF LEAK POINT** (while detail report of the leak point should be contained in the leak report, overview sketch of the site should be added as an appendix 1) A SECTION OF 24" (TNP) NKPOKU - BOMU PIPELINE AT NONKIA SHOWING A HACKSAW CUT AT 11 O'CLOCK POSITION BY UNKNOWN PERSON

REPAIR BY CLAMPING

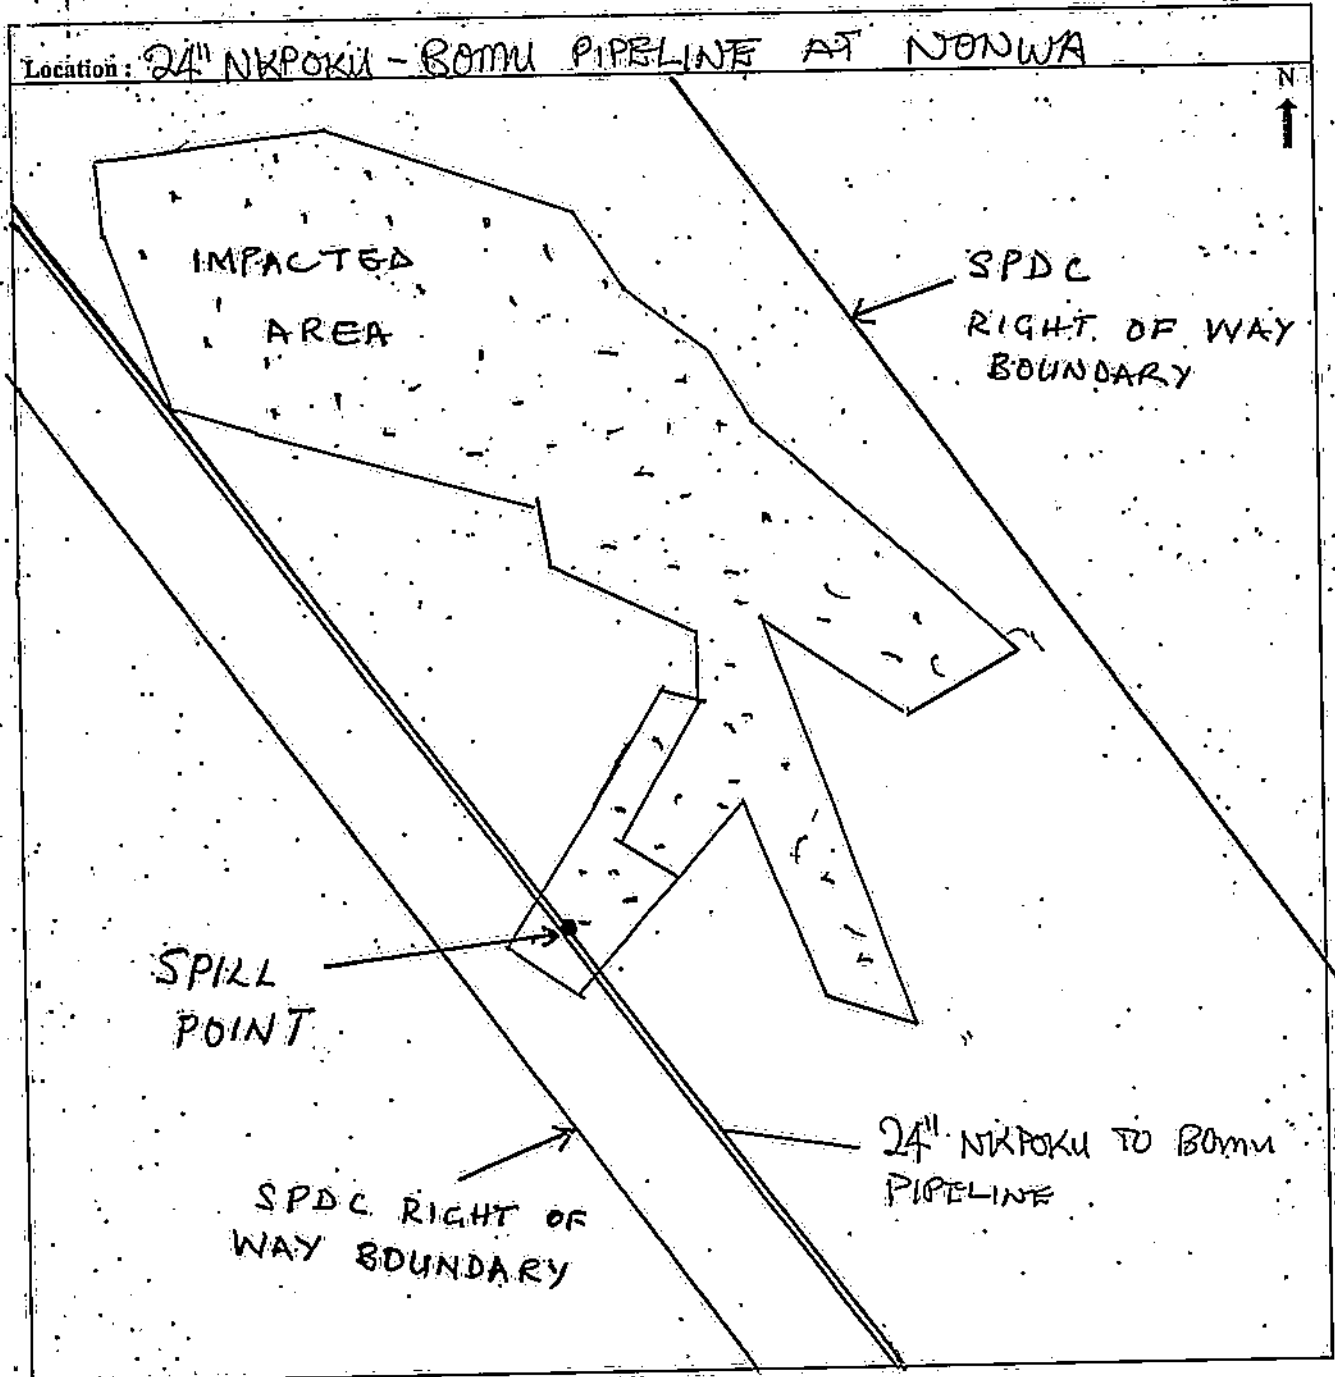
f. Appendix 1: Overview sketch of the site

- Total calculated area of impact 0.074 Ha
- Impact within SPDC R.O.W YES
- Impact outside SPDC R.O.W No
