JOINT INVESTIGATION REPORT

INCIDENT NO: 2505132 JIV report S/N: 1030168

1. Fountain Incident Number: 2505132 2. Type of incident* OIL SPILL
 3. Name of Location 24" NKPOKU - BOMU PIPELINE
 4. Name of nearest community KPITE 5. State: RIVERS 6. LGA TAI
 7. Type of Production facility/Installation OIL PIPELINE
 8. Asset owner/District THE SHELL PETROLEUM DEVELOPMENT COMPANY OF NIGERIA LIMITED (SPDC) / PIPELINE

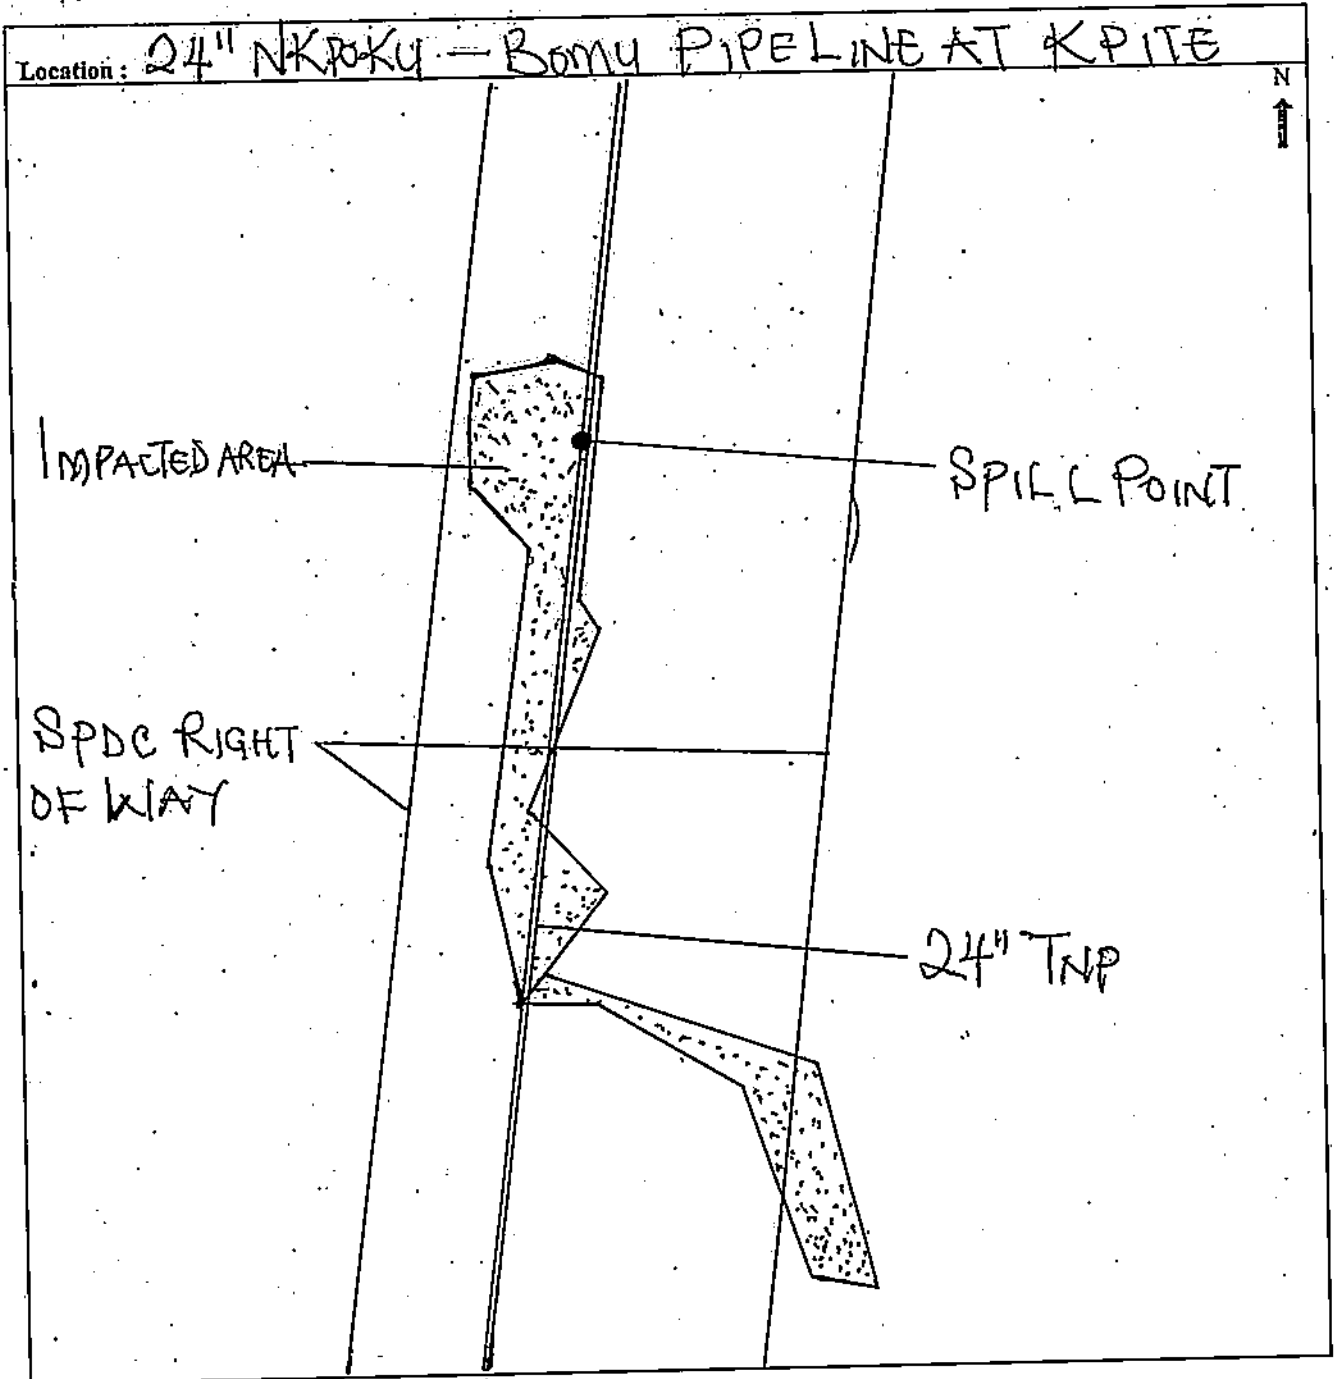
f. Appendix 1: Overview sketch of the site

E. GRAPHIC DESCRIPTION OF LEAK POINT (while detail report of the leak point should be contained in the leak report, overview sketch of the site should be added as an appendix 1) A SECTION OF 24" NKPOKU-BOMU TRANSVERSE NIGER PIPELINE AT KPITE SHOWING 6" WELDED FLANGE NECK AT 12 O'CLOCK POSITION BY UNKNOWN PERSON.

LEAK DUE TO 6" WELDED
FLANGE NECK AT 12 O'CLOCK
BY UNKNOWN PERSON
