# JOINT INVESTIGATION REPORT

INCIDENT NO: 2510377 JIV report S/N: 1030166

1. Fountain Incident Number: 2510377 2. Type of incident\* OIL SPILL  
3. Name of Location 2.8" BOMU - BONNY PIPELINE  
(PATRICK WATER SIDE)  
4. Name of nearest community BODO WEST 5. State: RIVERS 6. LGA GOKANA  
7. Type of Production facility/Installation OIL PIPELINE  
8. Asset owner/District THE SHELL PETROLEUM DEVELOPMENT COMPANY OF NIGERIA LTD (SPDC) / PIPELINE

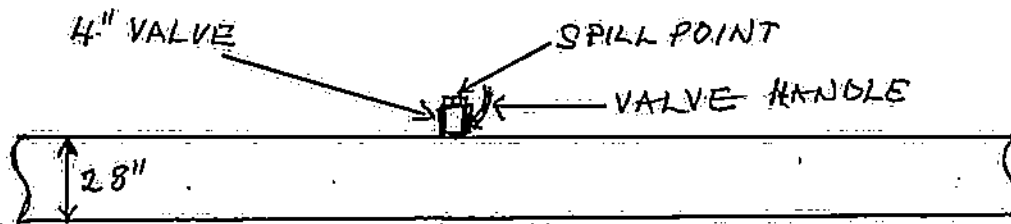
A SECTION OF 28" BOMU - BONNY PIPELINE AT BDD WEST SHOWING 4" VALVE CRUDE THEFT POINT INSTALLED AT 12 O'CLOCK POSITION BY UNKNOWN PERSON(S)
