JOINT INVESTIGATION REPORT

INCIDENT NO: 2517868 JIV report S/N: 1030181

1. Fountain Incident Number: 2517868 2. Type of incident* OIL SPILL
3. Name of Location 36" NKPOKU - BDMU PIPELINE
4. Name of nearest community RUMUESARA 5. State: RIVERS 6. LGA OBIO/AKPO
7. Type of Production facility/Installation OIL PIPELINE
8. Asset owner/District THE SHELL PETROLEUM DEVELOPMENT COMPANY OF NIGERIA LTD (SPDC) / PIPELINE

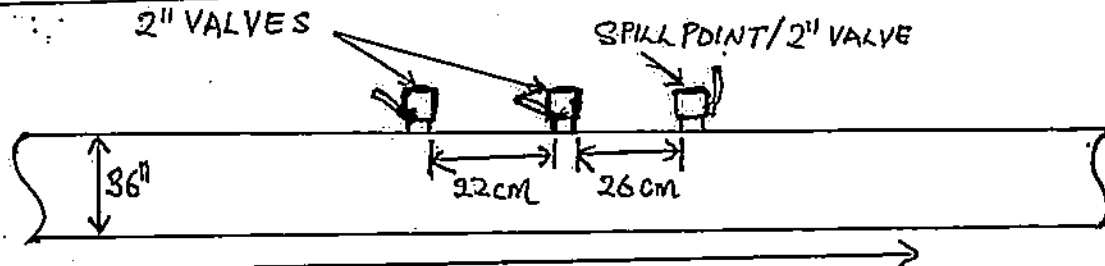
E. GRAPHIC DESCRIPTION OF LEAK POINT (while detail report of the leak point should be contained in the leak report, overview sketch of the site should be added as an appendix 1) A SECTION OF 36" NKPOKU - BDMU PIPELINE AT RUMUESARA SHOWING SNO: 2" VALVE CRUDE THEFT POINTS INSTALLED AT 12 O'CLOCK POSITIONS 22CM AND 26CM FROM EACH DONE BY UNKNOWN PERSONS.

NKPOKU TO BDMU

REPAIR BY CLAMPING
