JOINT INVESTIGATION REPORT

INCIDENT NO: 2513692 JIV report SIN: 1030177

1. Fountain Incident Number: 2513692 2. Type of incident: OIL SPILL
3. Name of Location: 14" OKORDIA - RUMUEKPO PIPELINE
4. Name of nearest community: IKARAMA 5. State: BAYELSA G 10A YENAGWA
7. Type of Production facility/Installation: OIL PIPELINE
8. Asset owner/District: THE SHELL PETROLEUM DEVELOPMENT COMPANY OF NIGERIA LIMITED (SPDC)/PIPELINE

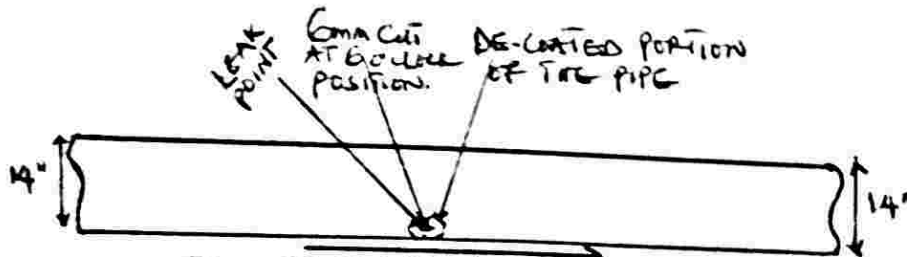
Others (specify) 6mm CUT (COATING WAS DE-COATED IN AN HEXAGONAL SHAPE WITH SHARP EDGES)

- Third party interference (Sabotage ; crude theft ; Line theft ; Accidental 3rd party damage
 Operational Others (including Mystery spills) (SUSPECTED EXTERNAL INTERFERENCE)

SECTION OF 14" OKORDIA-RUMUKPE PIPELINE AT IKRAMA SHOWING A 6mm CUT AND A DE-COATED PORTION OF THE PIPE AT 6 O'CLOCK POSITION DUE SUSPECTED EXTERNAL INTERFERENCE.
