JOINT INVESTIGATION REPORT

INCIDENT NO: 2473423 JIV report S/N: 1030117

1. Fountain Incident Number: 2473423 2. Type of incident* OIL SPILL
3. Name of Location 14th OKORDIA-RUMUEKPE PIPELINE
4. Name of nearest community IKATA 5. State: RIVERS 6. LGA AIHOADA EAST
7. Type of Production facility/Installation OIL PIPELINE
8. Asset owner/District THE SHELL PETROLEUM DEVELOPMENT COMPANY OF NIGERIA LIMITED (SPDC)/PIPELINE

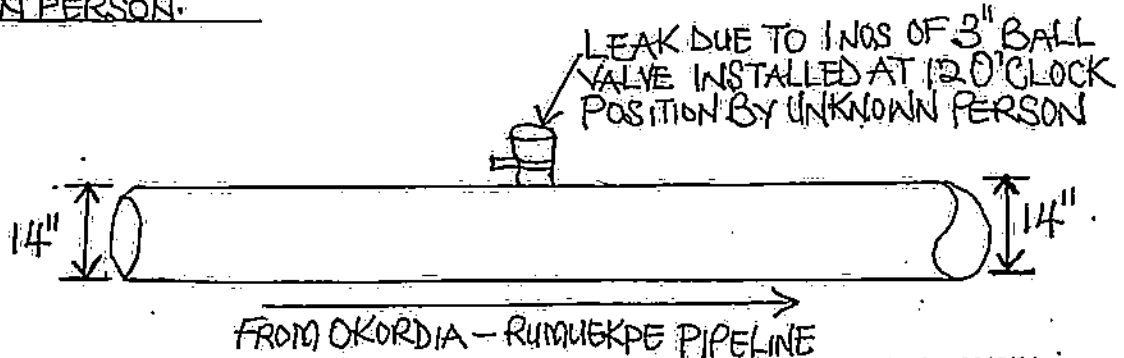
| <input checked="" type="checkbox"/> Crude oil theft (illegal bunkering) point, | <input type="checkbox"/> Saver-pit over flow | <input type="checkbox"/> Third party tampering with Clamp |

E. GRAPHIC DESCRIPTION OF LEAK POINT (while detail report of the leak point should be contained in the leak report, overview sketch of the site should be added as an appendix 1) A SECTION OF 14" OKORDIA - RUMUEKPE PIPELINE AT KATA SHOWING 3" BALL VALVE INSTALLED AT 12 O'CLOCK POSITION UNKNOWN PERSON.

REPAIR WORK ONGOING
