JOINT INVESTIGATION REPORT

INCIDENT NO: 2478772 JIV report S/N: 1030152

1. Fountian Incident Number: 2478772 2. Type of incident* OIL SPILL
3. Name of Location 14" OKORDIA - RUMUEKPE PIPELINE
4. Name of nearest community IHOWO 5. State: RIVERS 6. LGA ALUADA EAST
7. Type of Production facility/Installation OIL PIPELINE
8. Asset owner/District THE SHELL PETROLEUM DEVELOPMENT COMPANY OF NIGERIA LIMITED (SPDC) / PIPELINE

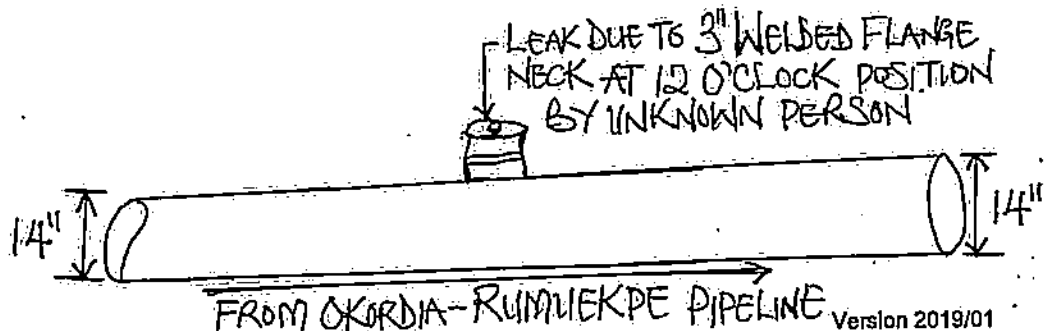
| <input checked="" type="checkbox"/> Failed Weld-on/illegal hot tap valve | <input type="checkbox"/> Failed Clamp, | <input type="checkbox"/> Missing Pipeline/Flowline |
| <input checked="" type="checkbox"/> Crude oil theft (illegal bunkering) point, | <input type="checkbox"/> Saver-pit over flow | <input type="checkbox"/> Third party tampering with Clamp |

E. GRAPHIC DESCRIPTION OF LEAK POINT (while detail report of the leak point should be contained in the leak report, overview sketch of the site should be added as an appendix 1) A SECTION OF 14" OKORDIA-RUMUEKPE PIPELINE AT HYDRO SHOWING 3" WELDED FLANGE NECK AT 12 O'CLOCK POSITION BY UNKNOWN PERSON

REPAIR WORK IN PROGRESS

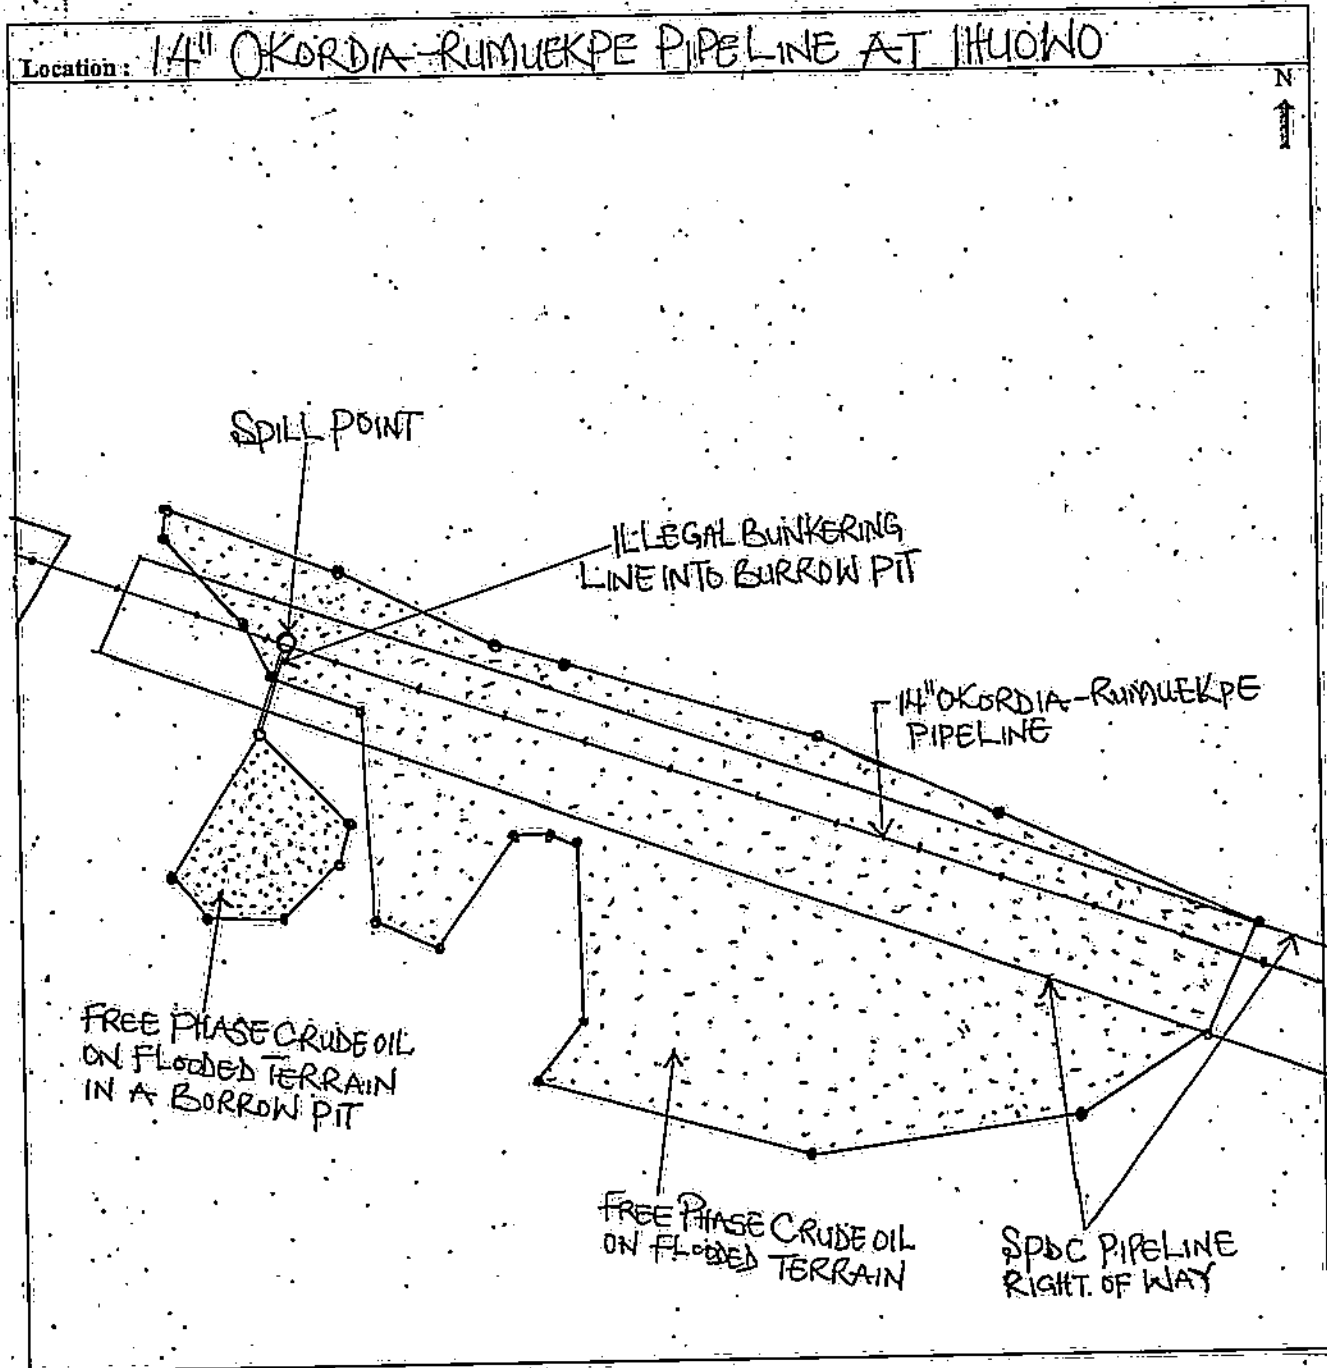
f. Appendix 1: Overview sketch of the site

- Total calculated area of impact: 0.77ha
- Impact within SPDC R.O.W: YES
- Impact outside SPDC R.O.W: YES
