# JOINT INVESTIGATION REPORT

INCIDENT NO: 2482402 JIV report S/N: 1030154

1. Fountain Incident Number: 2482402 2. Type of incident\* OIL SPILL  
3. Name of Location 12" IMO RIVER 2 - OGALE TIL ROW AT OGALE  
4. Name of nearest community KOM-KOM 5. State: RIVERS 6. LGA ELEME  
7. Type of Production facility/Installation PIPELINE  
8. Asset owner/District SHELL PETROLEUM DEVELOPMENT COMPANYCY NIGERIA LIMITED PIPELINE

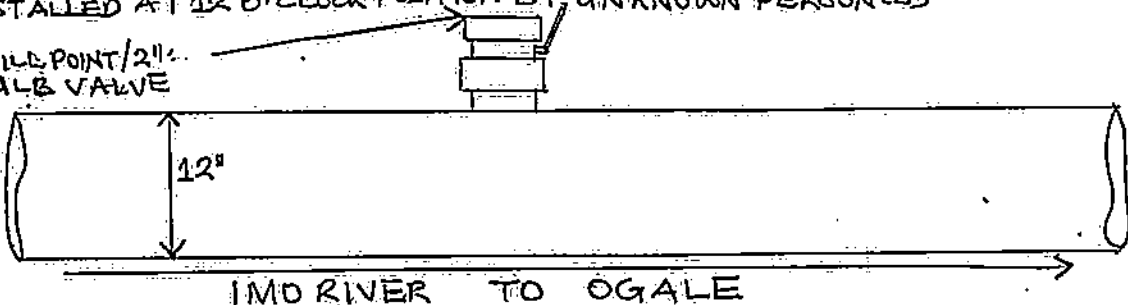
SPILL POINT/2" BALL VALVE

**E. GRAPHIC DESCRIPTION OF LEAK POINT** (while detail report of the leak point should be contained in the leak report, overview sketch of the site should be added as an appendix 1) A SECTION OF 12" IMO RIVER 2-OGALE PIPELINE AT OGALE SHOWING 2" BALL VALVE CRUDE OIL THEFT POINT INSTALLED AT 12 O'CLOCK POSITION BY UNKNOWN PERSON(S)
