# JOINT INVESTIGATION REPORT

INCIDENT NO: 2481601 JIV report S/N: 1030076

1. Fountain Incident Number: 2481601 2. Type of incident\* OIL ON SPDC RIGHT OF WAY  
3. Name of Location 24" TRANS ESCRAVOS PIPELINE  
4. Name of nearest community OGIDIGBEN 5. State: DELTA 6. LGA WARRI SOUTH-WEST  
7. Type of Production facility/Installation OIL PIPELINE  
8. Asset owner/District THE SHELL PETROLEUM DEVELOPMENT COMPANY OF NIGERIA

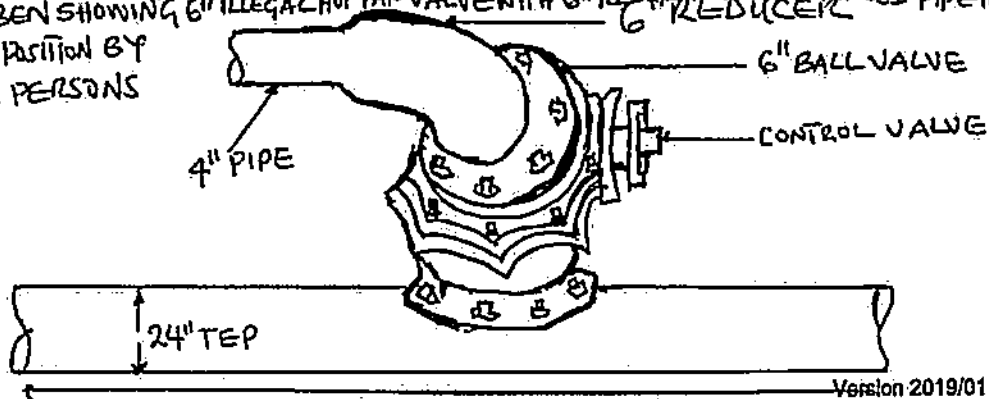
Additional observations around the spill point: THE JOINT INVESTIGATION TEAM OBSERVED 6" ILLEGAL HOT TAP VALVE WITH 6" REDUCER TO 4" EXTENDED PIPE (LEAKING) CONNECTED TO THE 24" TRANS ESCRAVOS PIPELINE. ALSO OBSERVED FREE PHASE CRUDE OIL ON RIGHT OF WAY

**E. GRAPHIC DESCRIPTION OF LEAK POINT** (while detail report of the leak point should be contained in the leak report, overview sketch of the site should be added as an appendix) A SECTION OF 24" TRANS ESCRAVUS PIPELINE AT OGI DIGBEN SHOWING 6" ILLEGAL HOT TAP VALVE WITH 6" REDUCER TO 4" EXTENDED PIPE INSTALLED AT 12 O'CLOCK POSITION BY UNKNOWN PERSONS

IN SERVICE WELDING
