JOINT INVESTIGATION REPORT

INCIDENT NO: 244.6383 JIV report S/N: 1030103

1. Fountain Incident Number: 2446383 2. Type of incident: OIL SPILL
3. Name of Location: 20" RUMUOKPE - NKROKU PIPELINE
4. Name of nearest community: IBAA 5. State: RIVERS 6. LGA: EMETHUA
7. Type of Production facility/Installation: OIL PIPELINE
8. Asset owner/District: THE SHELL PETROLEUM DEVELOPMENT COMPANY OF NIGERIA LIMITED (SPDC) / PIPELINE

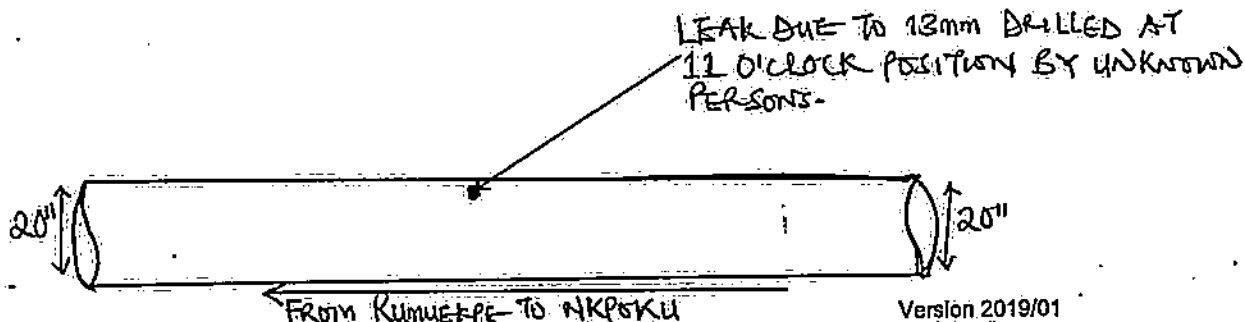
E. GRAPHIC DESCRIPTION OF LEAK POINT (while detail report of the leak point should be contained in the leak report, overview sketch of the site should be added as an appendix 1). A SECTION OF 20" RUMUEKPE - NKPOKU PIPELINE AT IBAA SHOWING A 13mm DRILLED HOLE AT 11 O'CLOCK POSITION BY UNKNOWN PERSONS.
