JOINT INVESTIGATION REPORT

INCIDENT NO: 2452373 JIV report S/N: 1030137

1. Fountain Incident Number: 2452373 2. Type of incident* OIL SPILL
3. Name of Location 24" BOMU - BONNY PIPELINE (TNP)
PATRICK WATERSIDE
4. Name of nearest community (BODO WEST) 5. State: RIVERS 6. LGA GOKANA
7. Type of Production facility/Installation OIL PIPELINE
8. Asset owner/District THE SHELL PETROLEUM DEVELOPMENT COMPANY OF NIGERIA LIMITED (SPDC) / PIPELINE

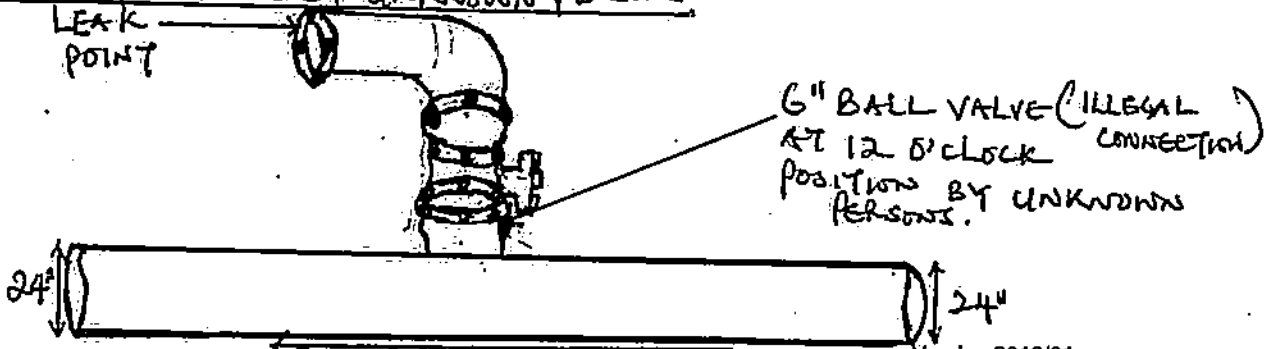
| <input checked="" type="checkbox"/> Failed Weld-on illegal hot tap valve | <input type="checkbox"/> Failed Clamp, | <input type="checkbox"/> Missing Pipeline/Flowline |
| <input checked="" type="checkbox"/> Crude oil theft (illegal bunkering) point, | <input type="checkbox"/> Saver-pit over flow | <input type="checkbox"/> Third party tampering with Clamp |

A SECTION OF 24" ROMU-BONNY PIPELINE AT PATRICK WATERSIDE SHOWING A 6" BALL VALVE (ILLEGAL CONNECTION) AT 12 O'CLOCK POSITION BY UNKNOWN PERSONS.

REPAIR ACTIVITIES ONGOING
