JOINT INVESTIGATION REPORT

INCIDENT NO: 2453085 JIV report S/N: 1030144

1. Fountain Incident Number: 2453085 2. Type of incident* OIL SPILL
3. Name of Location 16" EGBEMA - ASSA PIPELINE
4. Name of nearest community OBILE 5. State: IMD 6. LGA ORAJI/EGBEMA
7. Type of Production facility/Installation OIL PIPELINE
8. Asset owner/District THE SHELL PETROLEUM DEVELOPMENT COMPANY OF NIGERIA LIMITED (SPDC)/PIPELINE

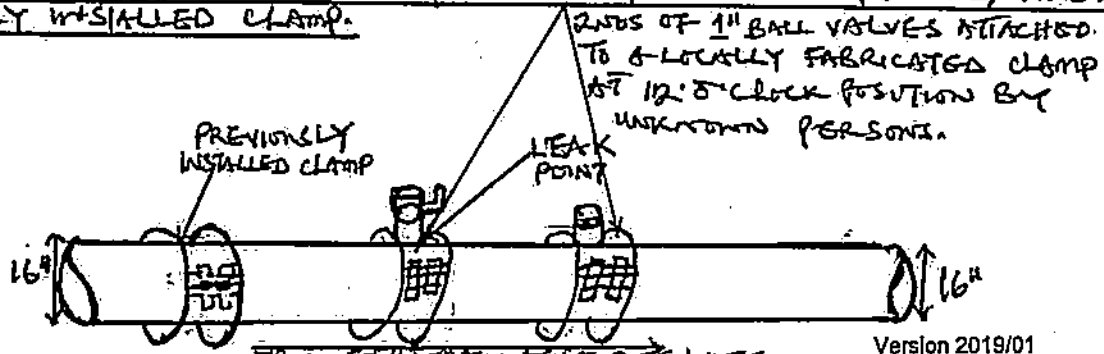
E. GRAPHIC DESCRIPTION OF LEAK POINT (while detail report of the leak point should be contained in the leak report, overview sketch of the site should be added as an appendix 1) A SECTION OF 16" EGBEMA-ASSA PIPELINE & HUNGRY RINGS OF BALL VALVES (1") ATTACHED TO 2" OF LOCALLY FABRICATED CLAMP AT 12 O'CLOCK POSITION BY UNKNOWN PERSONS, AND ALSO A PREVIOUSLY INSTALLED CLAMP.
