JOINT INVESTIGATION REPORT

INCIDENT NO: 2452344 JIV report S/N: 1030134

1. Fountain Incident Number: 2452344 2. Type of incident* OIL SPILL
3. Name of Location 14th OKORDIA - RUMUEKPE PIPELINE AT
4. Name of nearest community UKPELEDE 5. State: RIVERS 6. LGA AHOADA WEST
7. Type of Production facility/Installation OIL PIPELINE
8. Asset owner/District THE SHELL PETROLEUM DEVELOPMENT COMPANY OF NIGERIA LIMITED/PIPELINE

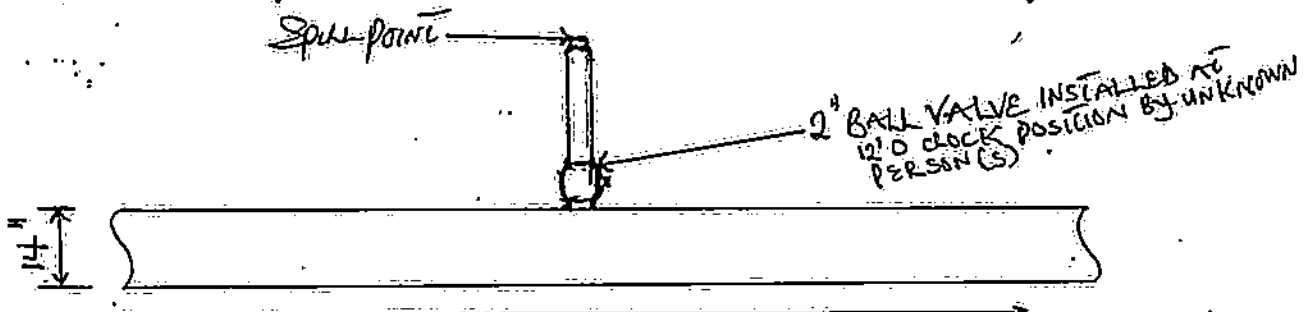
| <input checked="" type="checkbox"/> Failed Weld-on illegal hot tap valve | <input type="checkbox"/> Failed Clamp, | <input type="checkbox"/> Missing Pipeline/Flowline |
| <input checked="" type="checkbox"/> Crude oil theft (illegal bunkering) point, | <input type="checkbox"/> Saver-pit over flow | <input type="checkbox"/> Third party tampering with Clamp |

E. GRAPHIC DESCRIPTION OF LEAK POINT (while detail report of the leak point should be contained in the leak report, overview sketch of the site should be added as an appendix 1) SECTION OF 14" OKORDIA - RUMULEKE PIPELINE AT UKPELEDE SHOWING CRUDE LEAK POINT INSTALLED AT 12 O' CLOCK POSITION

CRUDE OIL RECOVERY AND REPAIR BY CLAMPING ONGOING
