JOINT INVESTIGATION REPORT

INCIDENT NO: 2449874 JIV report S/N: 1030141

1. Fountain Incident Number: 2449874 2. Type of incident* OIL SPILL
3. Name of Location 12" IMO RNER - OGALE (TRUNK LINE) PIPELINE
4. Name of nearest community OKOTHA 5. State: ABIA 6. LGA UKWA WEST
7. Type of Production facility/Installation OIL PIPELINE
8. Asset owner/District THE SHELL PETROLEUM DEVELOPMENT COMPANY OF NIGERIA LIMITED / PIPELINE

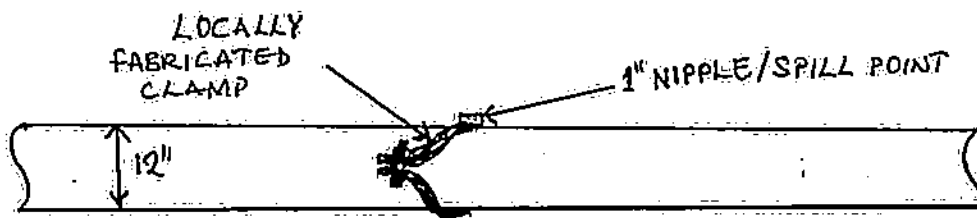
| <input checked="" type="checkbox"/> Crude oil theft (illegal bunkering) point, | <input type="checkbox"/> Saver-pit over flow | <input type="checkbox"/> Third party tampering with Clamp |

E. GRAPHIC DESCRIPTION OF LEAK POINT (while detail report of the leak point should be contained in the leak report, overview sketch of the site should be added as an appendix I) A SECTION OF 12" (MD RIVER-OGALE TRUNKLINE AT OKOHA SHOWING 1" ILLEGAL CONNECTION (LOCALLY FABRICATED CLAMP) INSTALLED AT 12 O' CLOCK POSITION BY UNKNOWN PERSON(S).

REPAIR BY CLAMPING ONGOING.
