JOINT INVESTIGATION REPORT

INCIDENT NO: 2460496 JIV report S/N: 1030116

1. Fountian Incident Number: 2460496 2. Type of incident* OIL SPILL
3. Name of Location 4" DBELLE - IBAA DELIVERY LINE
4. Name of nearest community IBAA 5. State: RIVERS 6. LGA EMOHUA
7. Type of Production facility/Installation OIL PIPELINE
8. Asset owner/District THE SHELL PETROLEUM DEVELOPMENT COMPANY OF NIGERIA LTD (SPDC)/PIPELINE

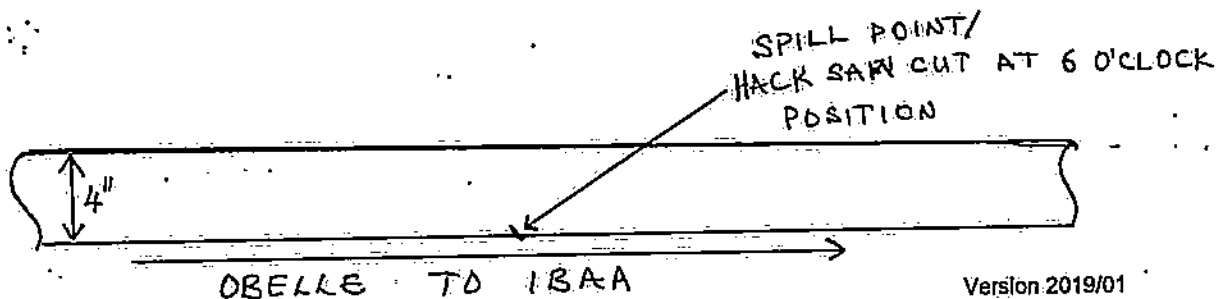
E. GRAPHIC DESCRIPTION OF LEAK POINT (while detail report of the leak point should be contained in the leak report, overview sketch of the site should be added as an appendix 1) A SECTION OF 4" OBELLE - IBA A DELIVERY LINE AT IBA A SHOWING 15MM HACK SAW CUT AT 6 O'CLOCK POSITION BY UNKNOWN PERSONS.

REPAIR BY CLAMPING

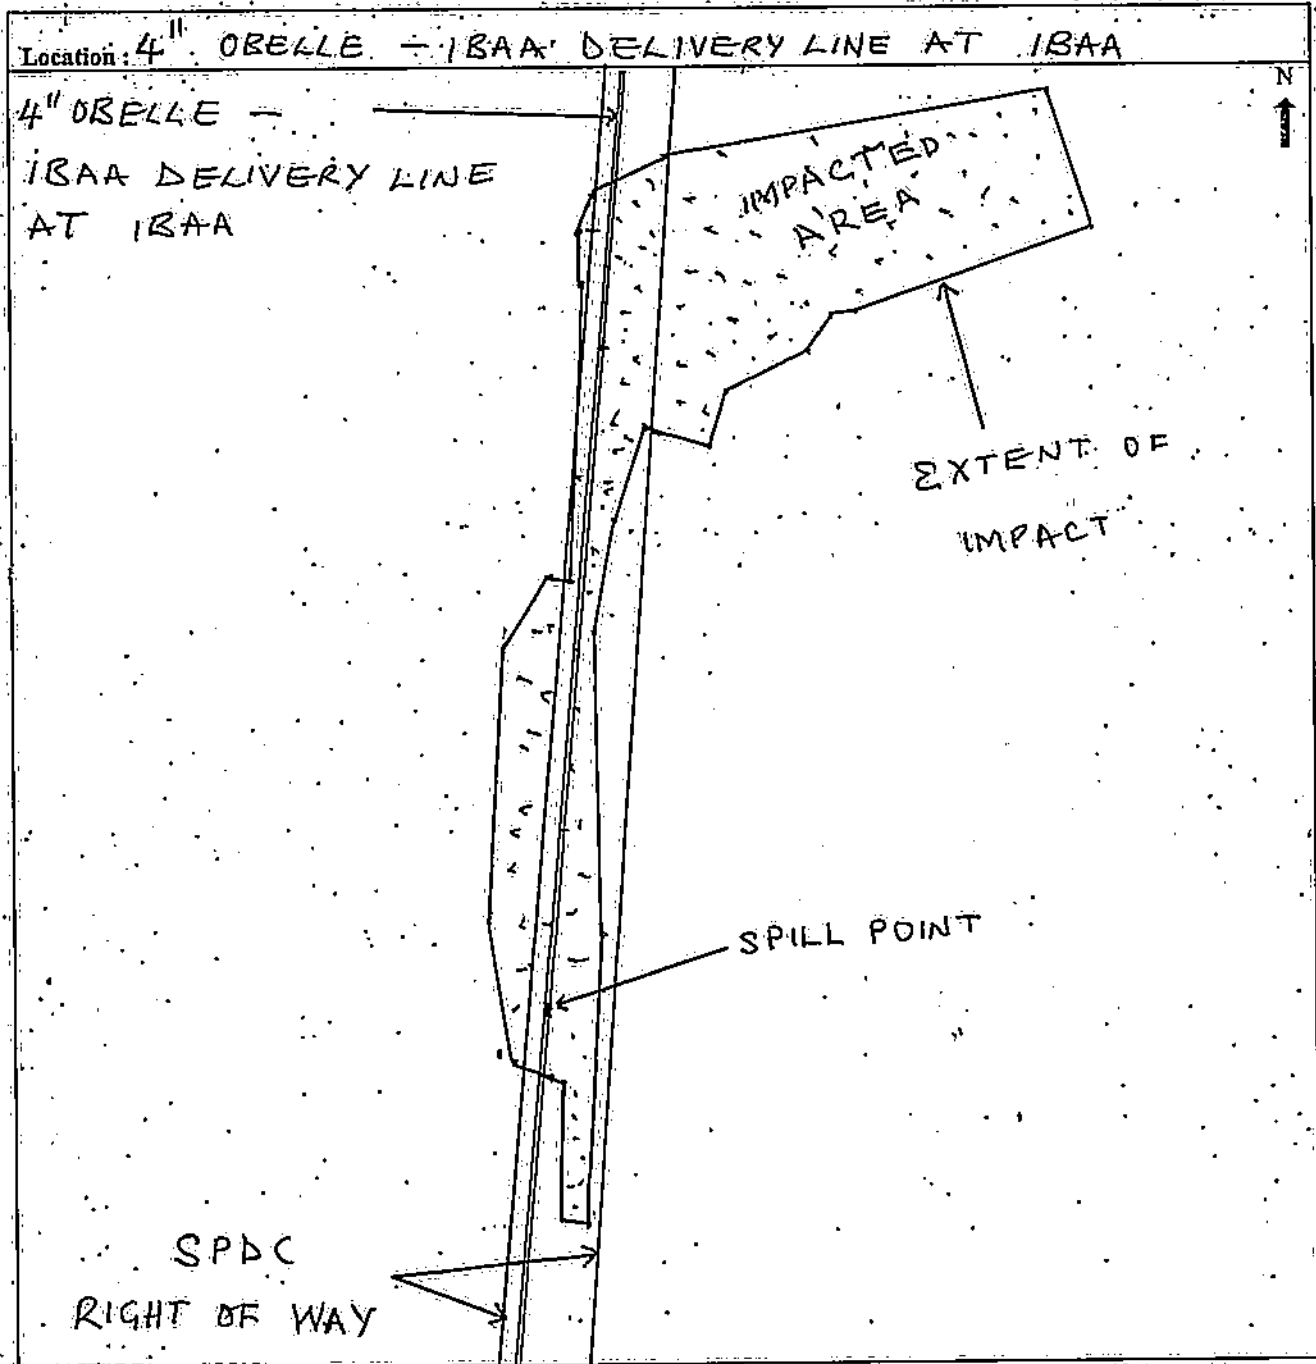
f. Appendix 1: Overview sketch of the site

- Total calculated area of impact: 0.909005 Ha
- Impact within SPDC R.O.W: YES
- Impact outside SPDC R.O.W: YES
