JOINT INVESTIGATION REPORT

INCIDENT NO: 2465248 JIV report S/N: 1030142

1. Fountain Incident Number: 2465248 2. Type of incident: OIL SPILL
3. Name of Location IMO RIVER WELL 33 WELL HEAD
4. Name of nearest community IPU WEST 5. State ABIA 6. LGA UKWA-WEST
7. Type of Production facility/Installation WELL HEAD
8. Asset owner/District THE SHELL PETROLEUM DEVELOPMENT COMPANY OF NIGERIA LIMITED / LAND EAST HUB

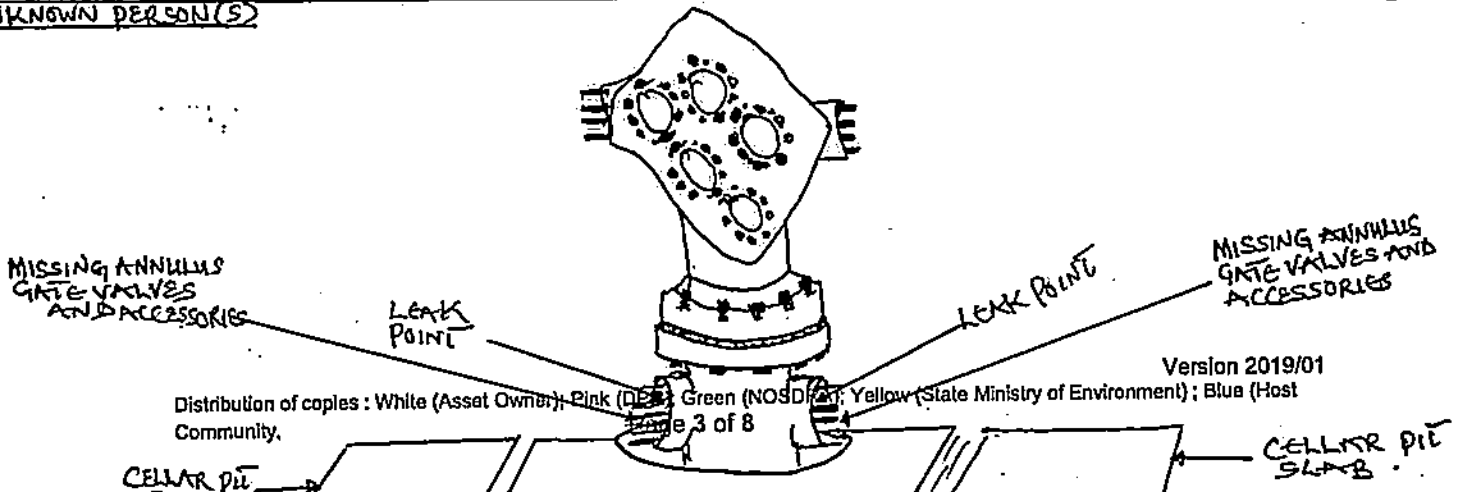
| <input type="checkbox"/> Complete Rupture | <input type="checkbox"/> Inward dent, | <input checked="" type="checkbox"/> Well head tampering |
| <input checked="" type="checkbox"/> Others (specify) <u>MISSING ANNULUS GATE VALVES AND ACCESSORIES</u> | | |

E. GRAPHIC DESCRIPTION OF LEAK POINT (while detail report of the leak point should be contained in the leak report, overview sketch of the site should be added as an appendix 1) SECTION OF IMO RIVER WELLS AT IPU-WEST (SWAZI) SHOWING MISSING ANNULUS GATE VALVES AND ACCESSORIES REMOVED BY UNKNOWN PERSON(S)

RECOVERY AND REPAIR ACTIVITIES ARE ONGOING.

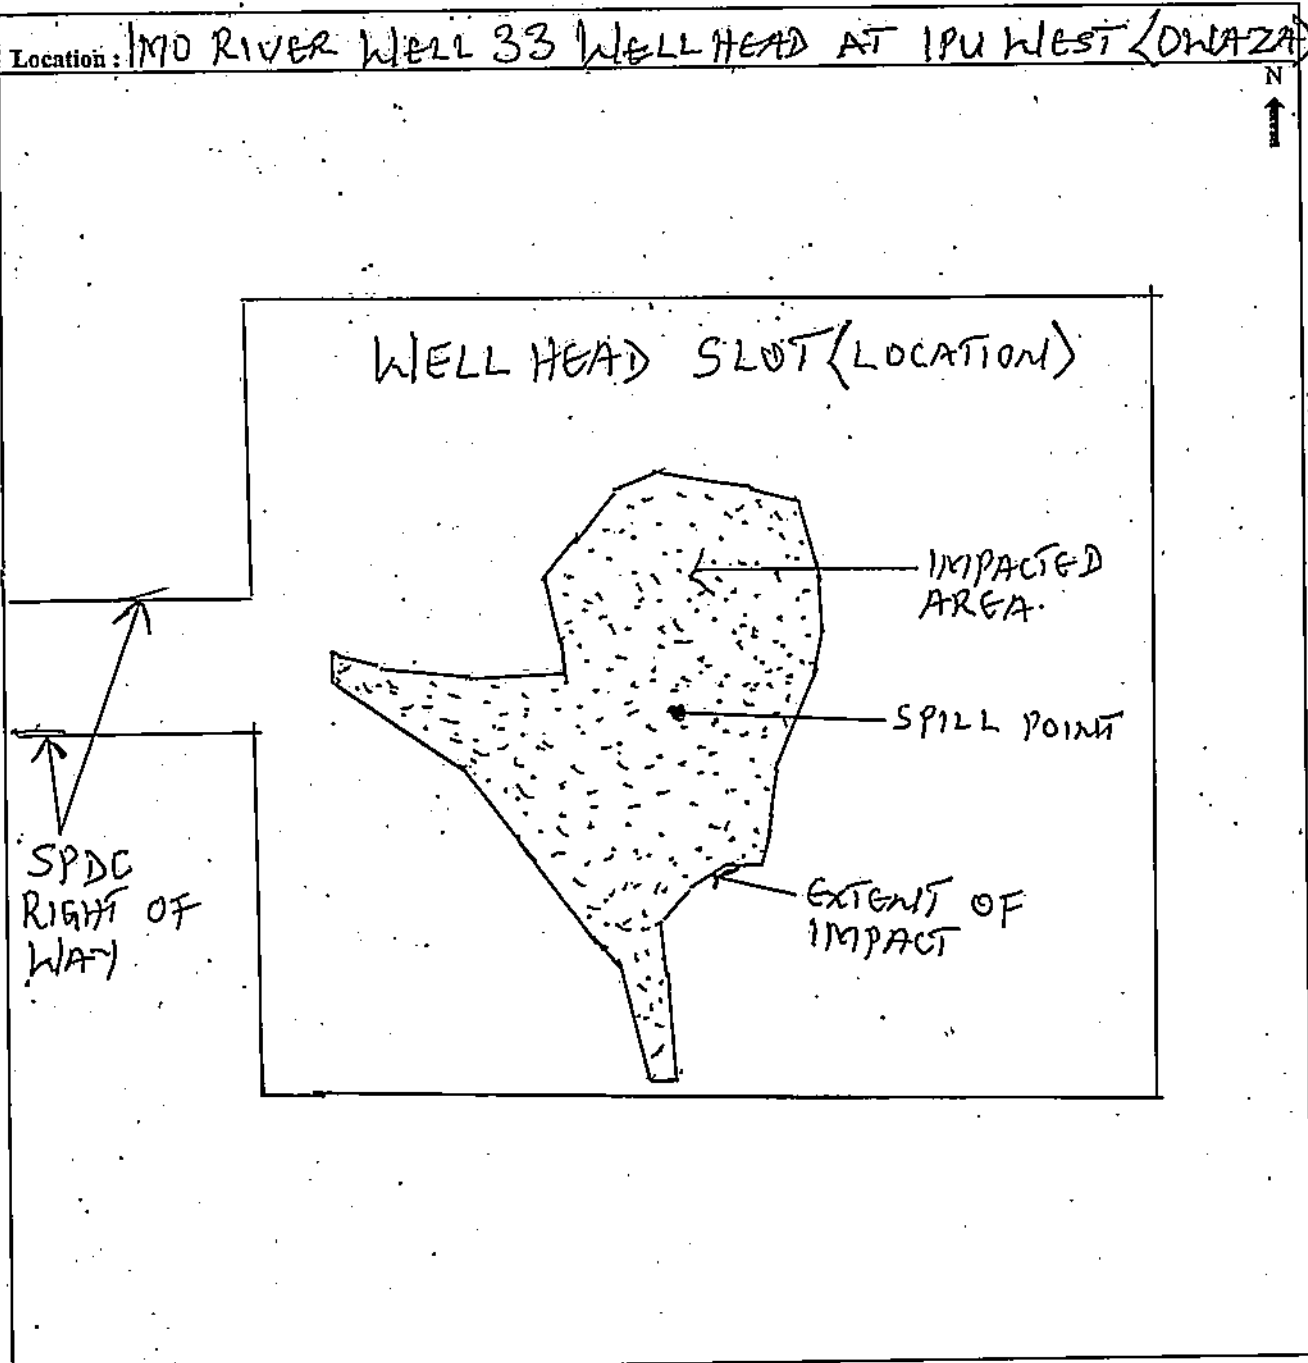
f. Appendix 1: Overview sketch of the site

Spill on Imo River Well 33 Well Head at Igiriukwu- Owaza
