JOINT INVESTIGATION REPORT

INCIDENT NO: 2622159 JIV report S/N:

1. Fountain Incident Number: 2622159 2. Type of incident* OIL SPILL
3. Name of Location 28" BOMU - BONNY PIPELINE
4. Name of nearest community BODO 5. State: RIVERS 6. IGA GOKANA
7. Production Facility/Installation OIL PIPELINE
8. Asset Owner/Hub THE SHELL PETROLEUM DEVELOPMENT COMPANY OF NIGERIA LTD (SPDC) / PIPELINE

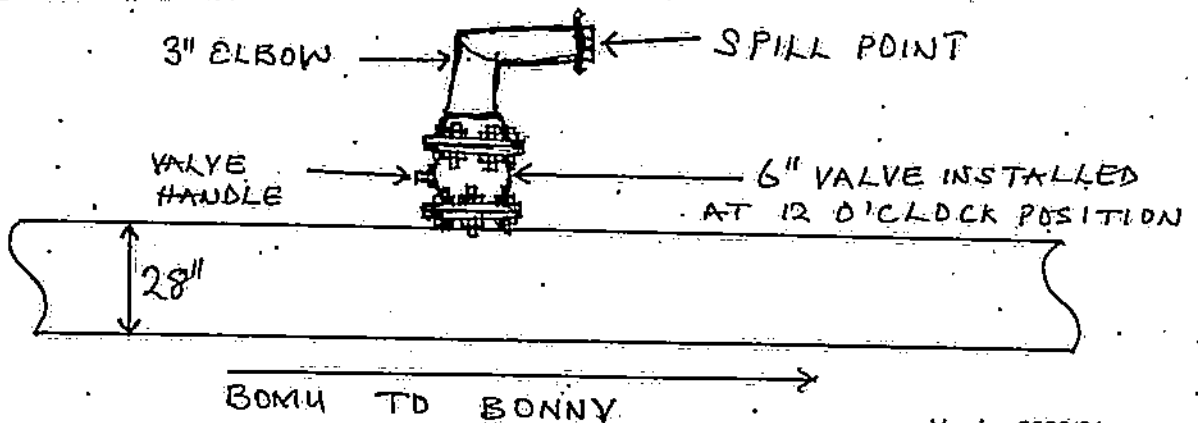
E. GRAPHIC DESCRIPTION OF LEAK POINT (while detailed description of the leak point should be contained in the leak report, overview sketch of the site should be added as appendix 1) A SECTION OF 28" BOMU - BONNY PIPELINE AT BODO (PATRICK WATER SIDE) SHOWING 6" CRUDE OIL THEFT VALVE INSTALLED AT 12 O'CLOCK POSITION BY UNKNOWN PERSON(S)

BLIND FLANGING
