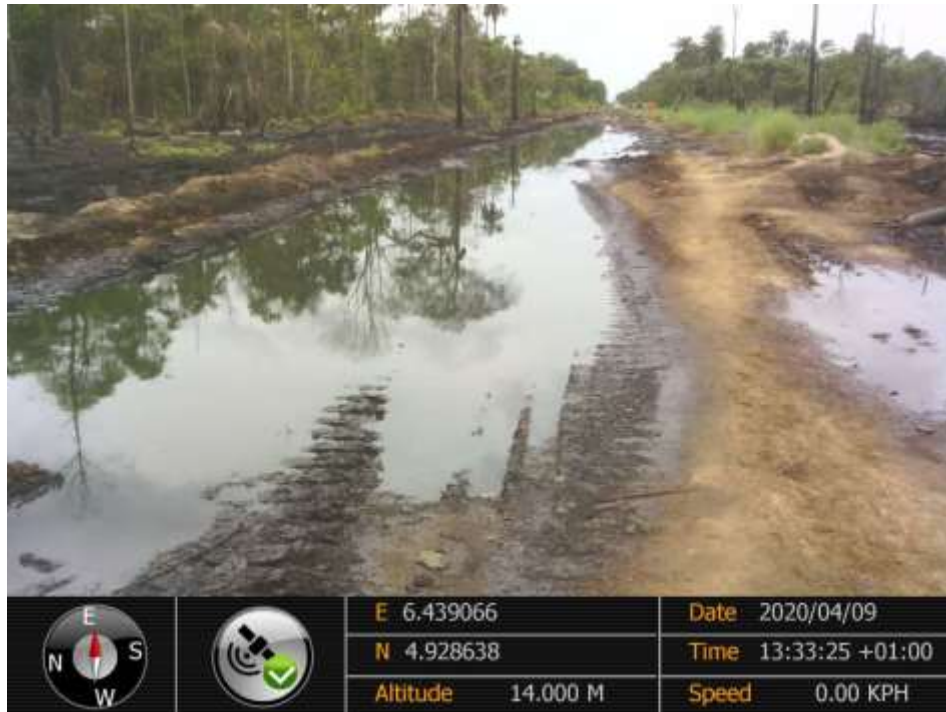
Overview: Part of spill impact on 20" Kolocreek-Rumuekpe Pipeline at Odau-KP9. Picture was taken during Joint Investigation of 9th April 2020.

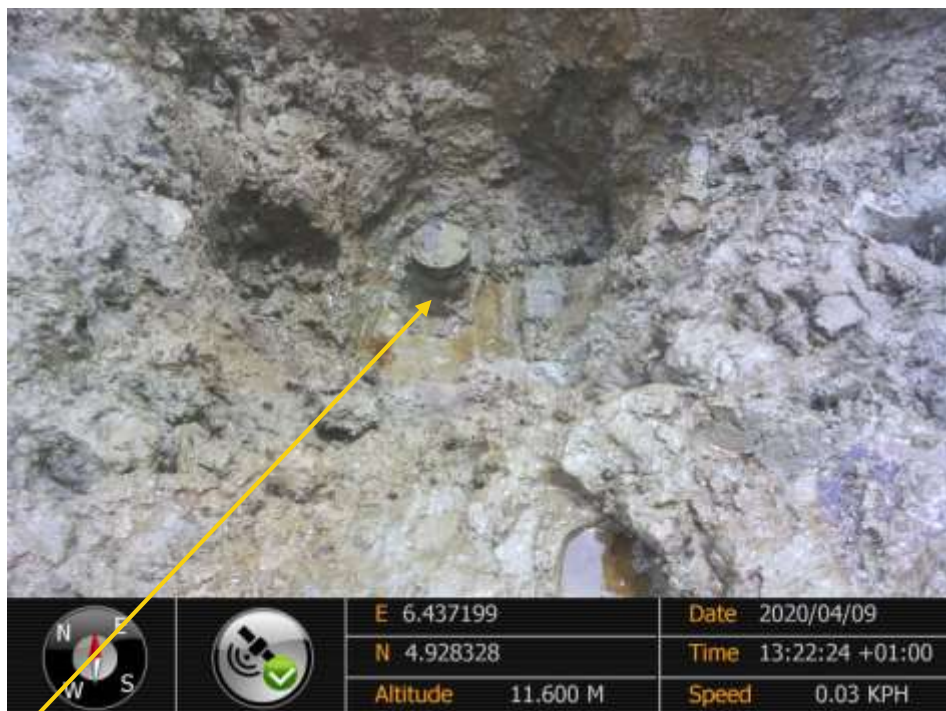
Close-up: 3" ball valve flange installed at 12 o'clock position on 20" Kolocreek-Rumuekpe Pipeline at Odau-KP9. Picture was taken during Joint Investigation of 9th April 2020.
